## ASCERTAINING THE TECHNICAL STATE OF THE "TRIPOD" ASSEMBLY OF A MINING EQUIPMENT - PART II

**ABSTRACT:** In this paper are presented the methods of ascertaining the technical state of a mining machine and their method of application. Taking these methods into account, the technical expertise of the tripod support assembly of a coal extraction machine is presented. After performing the technical expertise, there are presented the found defects. The rehabilitation to which the assembly will be subjected will be done by the workmanship of the intervention work that will bring back to the normal operating parameters both the structural and the functional part.

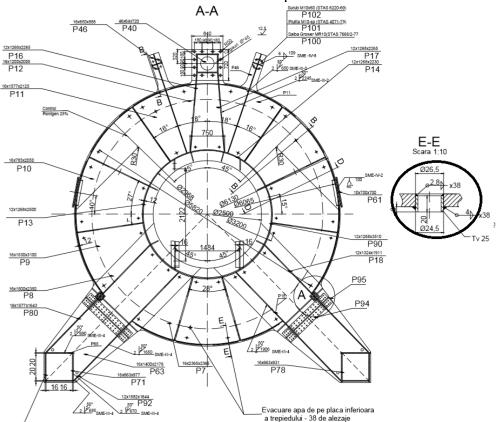
The arrangement of the drain holes is shown in picture 3, 38 bores are carried out on the lower plate of the tripod.

Picture 3. The correct arrangement of the 38 rainwater drainage holes.
