REGARDING THE QUALITY OF THE VEHICLE BACKSEAT FRAME ARMATURE RS 60%

Abstract: This paperwork identifies the unconformity from the backseat frame armature RS60% welding of a vehicle, respective the seatbelt bracket position. Causes and fixing that the seatbelt bracket not to be able to rotate around its axis.

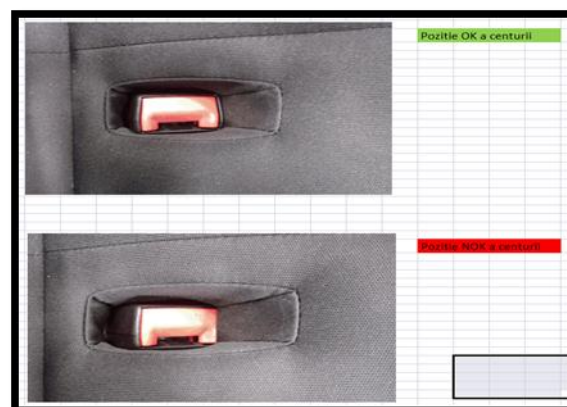
Fig.6 The OK and NOK of a seatbelt

One of our client claim is the unconfirmed position of the seatbelt bracket, the client is accusing a bigger angle for the seatbelt bracket fixing. It was found a structure with a seatbelt bracket angle of 37° instead of 34° as seen in figure 6. After the 3D measurements the client claim was confirmed.

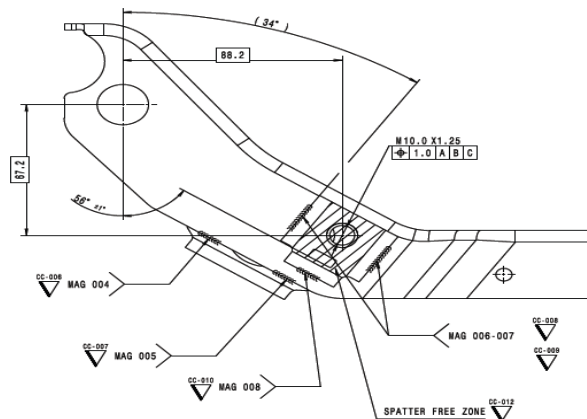
Fig.7 The execution drawing of the seatbelt bracket hardened subsystem

In the figure 7 the execution drawing of the seatbelt bracket hardened subsystem is presented. It is observed that the angle for the seatbelt bracket fixing is 34° . Through this study the root of this unconformity is determined.

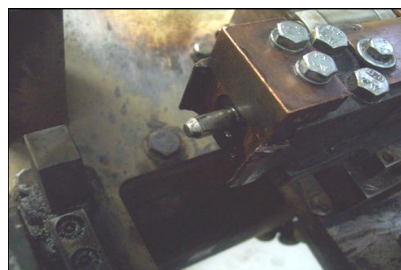
Fig.11 The alignment device for the seatbelt bracket.

After this study it was found out that the welding device was the main cause for the unconformity. Through a detailed analysis it was concluded that the welding device allowed the seatbelt bracket to rotate around its screw nut during its laying down on the welding device ,figure 11.
