SOME ASPECTS REGARDING THE TECHNICAL EXPERTISE OF THE ROTATION PLATFORM OF THE COAL EXTRACTION MACHINE

Abstract: *In this paper presents the technical state in which the rotating platform of the coal-mining machine is located, after performing the technical expertise. The rehabilitation to which the rotating platform will be subjected will be accomplished by performing the intervention works that will return to its normal operating parameters. The paper presents the defects found on the rotating platform as well as the proposed solutions for its repair.*

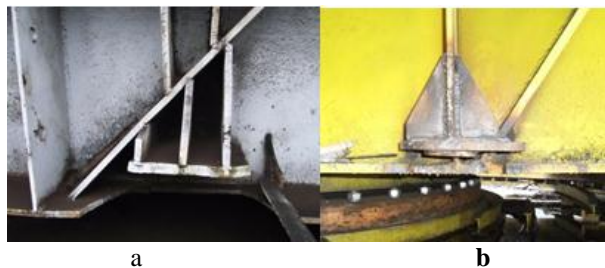
Following the technical expertise of the rotary platform of the coal-mining machine, a number of technical irregularities and malfunctions [5],[6]. Thus, the positioning of lifting brackets by means of presses, when changing the bearing is wrongly performed on the coal extraction machine, fig.2,a.

Fig.2. Placement of supports: a-incorrect; b-correct.

Their correct position was executed on a machine in another device, with a design that complied who respect the closure of the efforts in the building nodes on the part side, rear, fig. 2, b.

The wrong execution of the two-point lifting supports does not support the support tripod, deforming or even even leading to operating accidents. For this reason, the execution must be done at a point, on its face, providing 3-point support, with the correct support control.

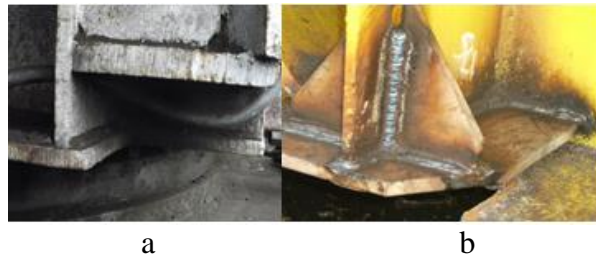
Fig.3. Execution of lifting bracket welding.

It has also been found that the execution of the welding of the lifting brackets is wrong being made in front, from two points (correct is in the face at one point). Execution must be done at a point, on its face, providing 3-point support, with the correct support control. The welds between the sloping soles and the upper and lower plates of the platform on the outside, fig.4, right-left have defects (on US control) on both the upper and the lower ones - they will restore to repair on both sides of the main beams.

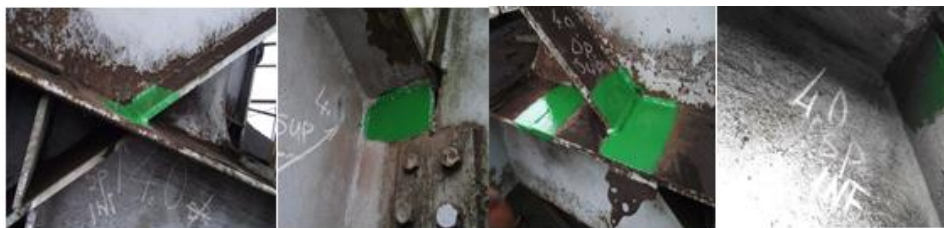
Fig.4. Welds between inclined soles and the top and bottom plates of the platform.

Instead, in controlling the weld on the upper base plate, it was found that it has no

defects. The welding rehabilitation will be done by cutting, then it will be cleaned by polishing and and it will be done the control with penetrating liquids (LP) of the area, and finally a new welding.

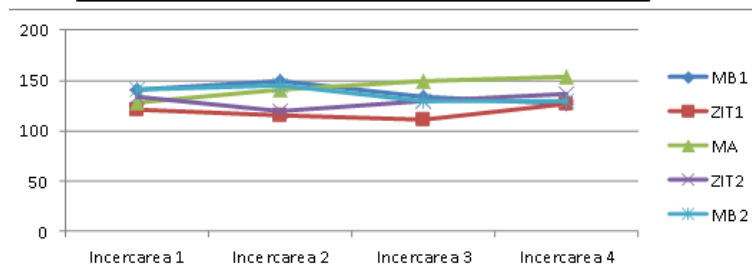
The hardnesses, for the welded of type head-to-head joint on the upper plate of the rotating platform, are the normal ones, with the welding properly executed having the basic materials listed in the basic documentation. The control with Lp and US did not reveal defects that to did not meet the quality class [7], and [8].

Fig.5. Determining the hardness values graph.

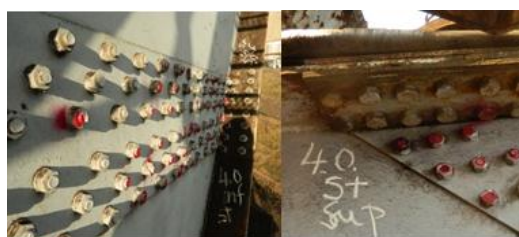
When assembling the balancing arm on the rotating platform with bolts, it was found that the clamping system of the soles and the core of the "I" welded beam profile between the two subassemblies, has been realized with IP (IR) group 10.9 screws. Also, there was found a very advanced oxidation of the heart on the inner side, at catching on the upper base plate, but also between the strap and the sole. Here it is necessary the plating on the inside, after cleaning and measuring, followed by anticorrosive protection.

Fig.5. Bookmarks with the red paint of the screws that vibrates.

They have been checking the screws by the impulse method and where the screws vibrated, it was necessary to check them with the torque wrench set at $1.2 * M_{tn}$, fig.5. The screws that vibrated were marked with red paint. Verification of the bolts by this method was repeated on both joists in the joint construction on both the left and the right side of the metal construction.

For reinforcement plating, the newly designed solution and consumptions will be introduced, including the replacement screws and straps on the joint of the soles.
