## **ASPECTS REGARDING EXPERTISE OF THE ORIZONTALIZATION DEVICE OF COMMAND CABINE OF THE COAL MINING MACHINE**

**ABSTRACT:** This paper presents the technical state of the device for the alignment of a coal-mining machine after the technical expertise. The rehabilitation to which the control cabinet will be subjected will be carried out by performing the intervention works that will restore the normal operating parameters of both the structural part and the functional part. In the paper are presented: the means of verification of the device and the proposed technical solutions for the repair of the device.

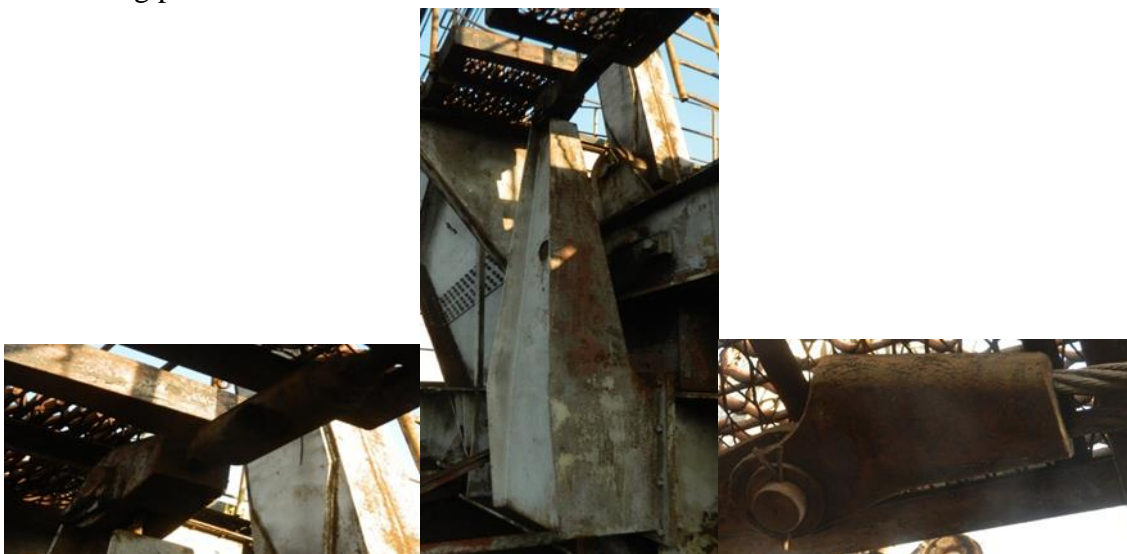
Control bolts and cable lugs. Rust is observed who attacked the paint on the component parts including the inside of the cable lug. Check that the holder is secure of the rotating platform.

**Fig.2 Photos with defects**

Control bolts and cable lugs.

It can be noted the rust that attacked the paint on the component parts including the inside of the cable lug.

Observe that attacked rust paint on the components including cable inside the puck. Check the rotating platform mounting bracket. Painting will follow the instructions of the standards.

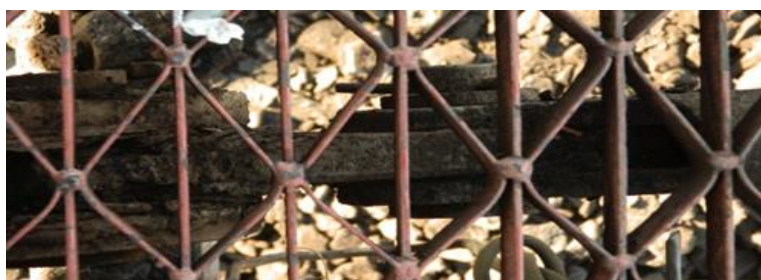
Gripping the support frame, the clamping ear of the frame on which the control cabinet is fixed, which oscillates with the frame.

**Fig.3 Gripping of the support frame**

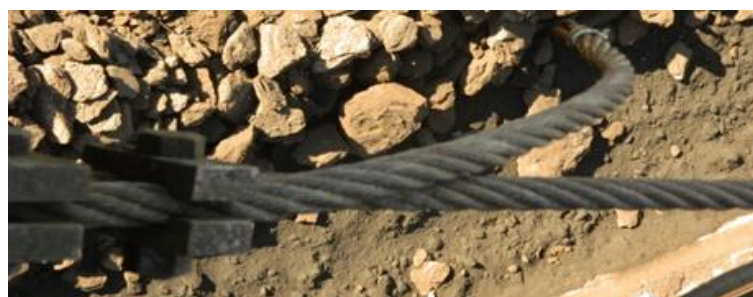
The cab for maintaining the cabin in the horizontal position is not secure, without clamps as required by the documentation. They will be repaired; cable lug + lock and connecting bolts.

**Fig4 Cord retaining cable in the horizontal position**

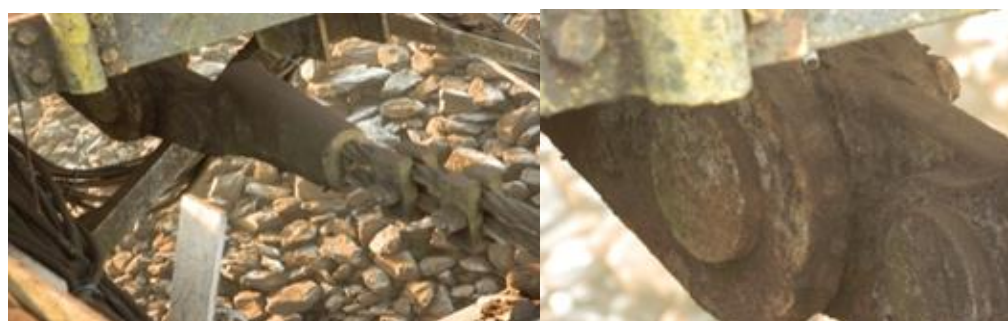
The cable support attachment assembly is strongly corroded.

The repair is impetuously urgent because it jeopardizes the machine-serving machine. Figures 3, 4 and 5 illustrate the support frame

**Fig.5 The gripping assembly of the cable support**

The pronounced degradation of the slipper-socket assembly under the cabin floor that holds the support and horizontal cable and requires URGENT intervention and control by a workshop specialized in repairs.

Mounting additional cable clamps to the exit of the slipper so that the free ends fit correctly and parallel to the sack assembly.
