ASPECTS RELATING TO EXPERTISE OF THE MAST COAL MINING MACHINES – THE FIRST PART

ABSTRACT: This paper presents the technical state of the mast of a coal-mining machine, following technical expertise. The rehabilitation to which the mast will be subjected will be done by carrying out the intervention works which will restore in the normal operating parameters both the structural part and the functional part.

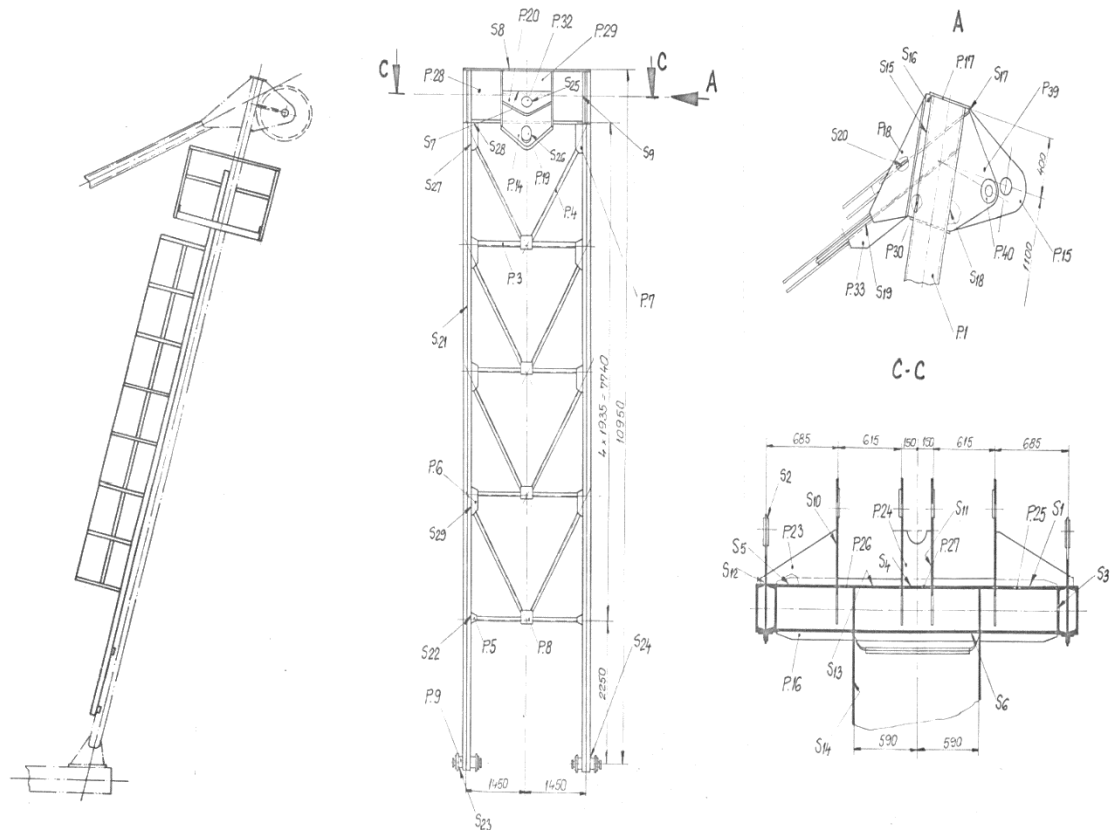
Fig.1 Outline of the ensemble "Pillar" with details

The view area in "A" of the sketch below is strongly requested.

The "C-C" section area required both on the front and the rear to the traction by the cable hook at the rear and the front swinging need to be deepened during the expertise but will be followed by a very careful handling in

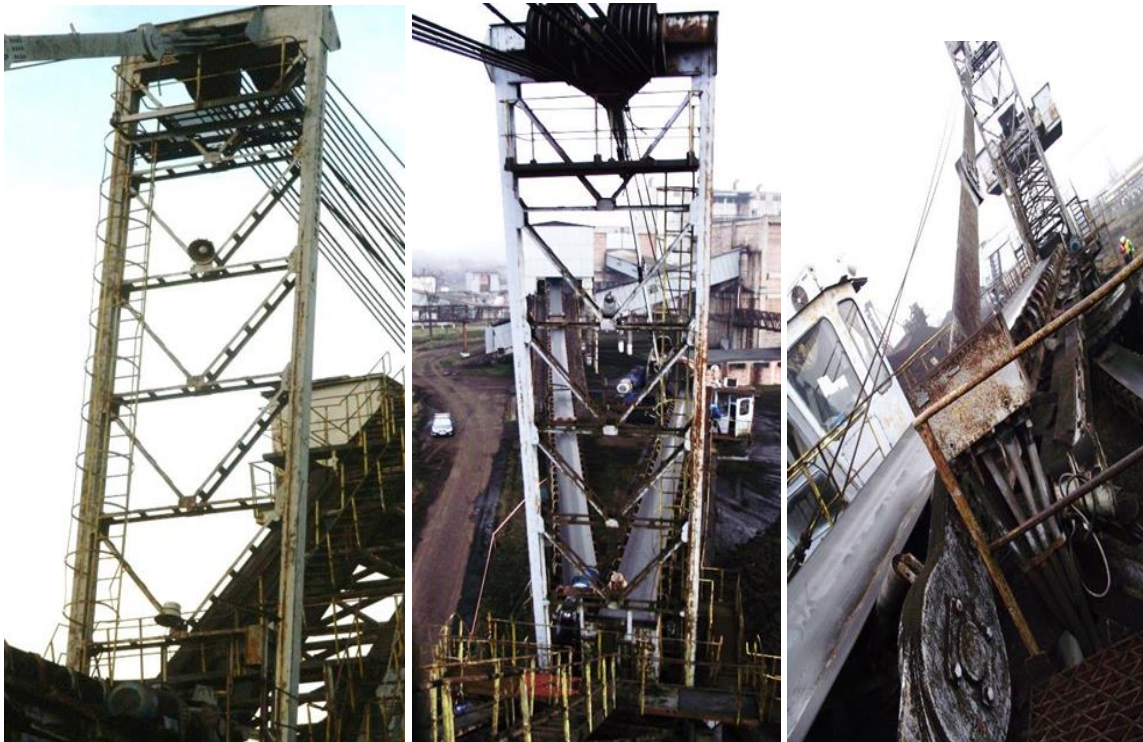
Fig.2. Mast views

The assembly as seen in the views of Fig. 2 does not have serious degradations, but we will still show the places where some minor repairs are required.

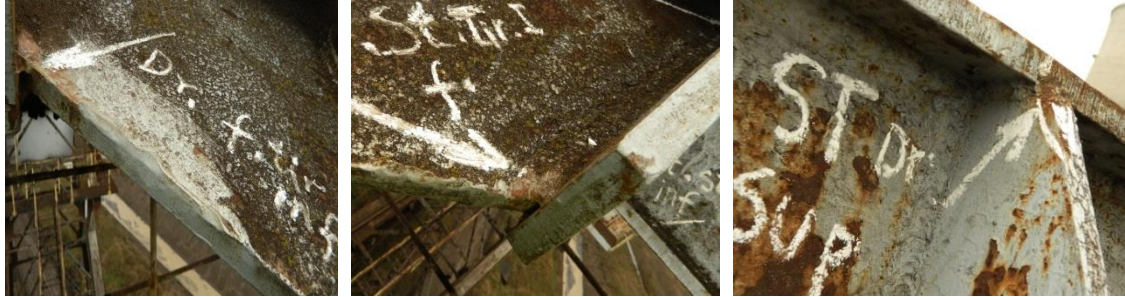
Rust attacked the paint from the upper part of the mast and penetrated the welded sheets in the end gap at unsealed welds.

Fig.3 Rust attacked the paint

Welding control has shown that there are areas with incomplete and unsealed welds, will be restored and then repaired with penetrating liquids.

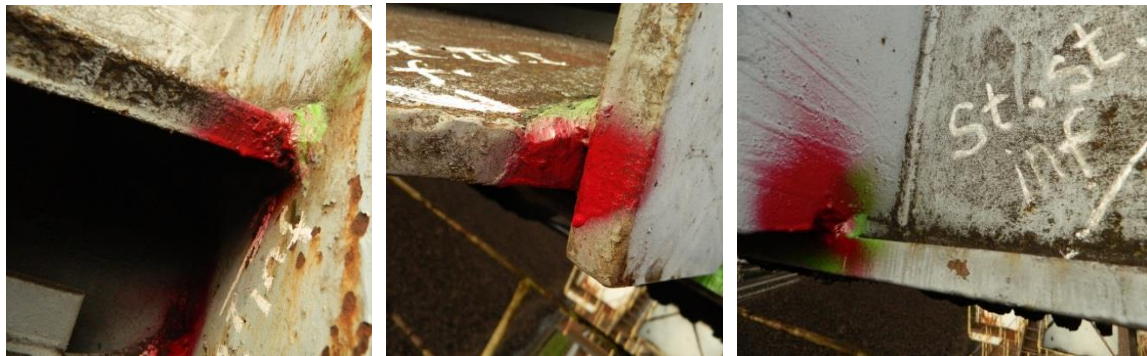
Fig.4 Incomplete welds

Incomplete welds will be repaired, the areas painted red to be easily visible during repair.

They are located in places difficult to reach and at high places and as a result special safety measures will be taken during welding.

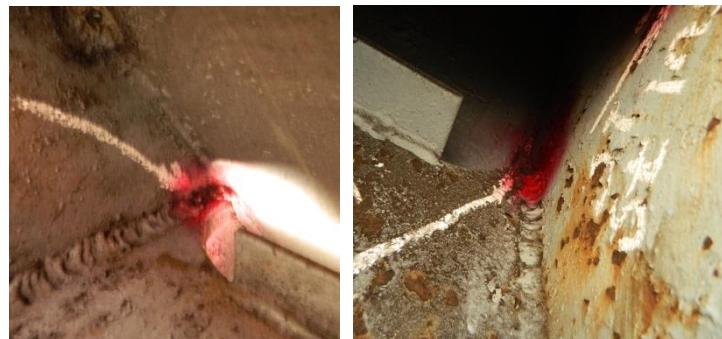
Incomplete welds in hard-to-reach areas that will be repaired on repair, the areas painted red. The rust that attacked the paint at the top

of the mast and penetrated between the welded sheets in the end gap at unsealed welds.

Fig.5 Incomplete welds in hard-to-reach areas

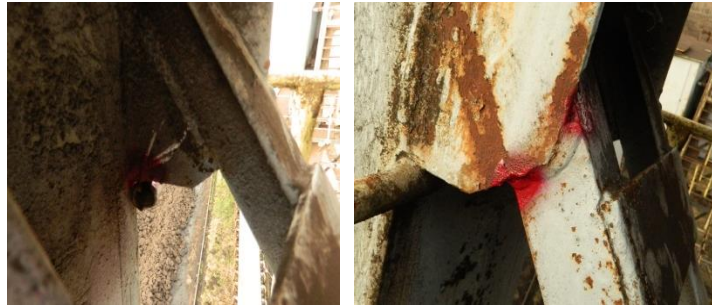
Welding with marginal burns to be repaired on repair, areas painted red. The rust that

attacked the paint at the top of the mast beam both on

Fig.4 Welding with with marginal burns

the outside and hardly accessible areas, the cleaning and dyeing will be performed

following the instructions attached to this expertise.
