ASCERTAINING THE TECHNICAL STATE OF THE "TRIPOD" ASSEMBLY OF A MINING EQUIPMENT - PART I

ABSTRACT: In this paper are presented the methods of ascertaining the technical state of a mining machine and their method of application. Taking these methods into account, the technical expertise of the tripod support assembly of a coal extraction machine is presented. After performing the technical expertise, there are presented the found defects. The rehabilitation to which the assembly will be subjected will be done by the workmanship of the intervention work that will bring back to the normal operating parameters both the structural and the functional part.

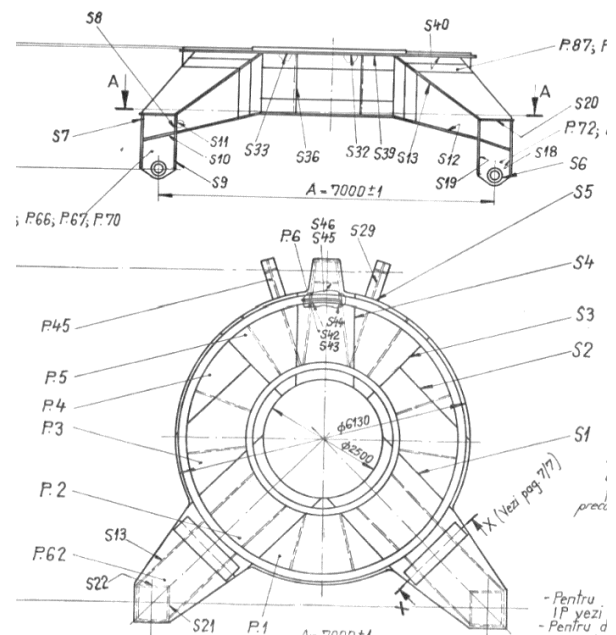
Fig.1. Sketch - support tripod

The support tripod is an assembly that is part of the metal construction of the coal pick-up machine along with the armrest wheel, tie rod I and tie rod II, the horizontal control device, the rotary platform and the balancing arm. The sub-assembly being placed on the running and running mechanism of the car supports the entire upper construction and as a result of its importance, a greater attention was given to the technical expertise on it. The supports A and B are assembled on the tripod with the help of the IR preliminary strained screws from gr. 10.9. The latter presents a series of non-conformity which is why they must be removed in the process of repair that will follow. The sketch of the support tripod is shown in picture 1.

The restoration and completing of the welds, picture 1.a, will be done with the car suspended on the presses at the special lifting

points provided in the construction of the car, the polishing with the radius of the corners at the boxes and / or sheet marks, picture 1.b. In order to be able to easily identify defects and / or non-conformity parts of the components of the tripod, they were painted red.

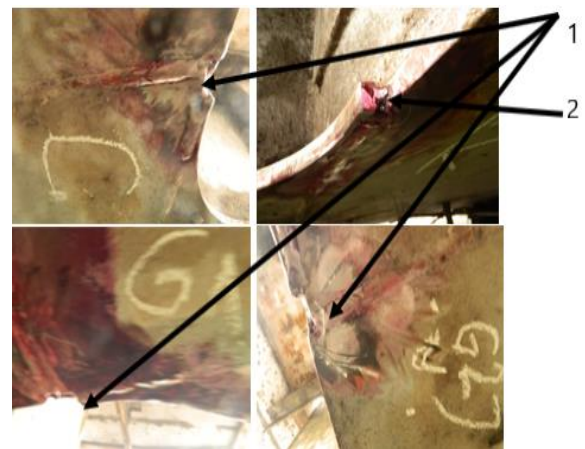
Fig.2. Bottom plate - welding defects.

All X-welds on the lower plate were controlled and did not have defects in the weld, the control was performed with ultra sound (US) and fluids. At the welded plate - position 6, S45, S46

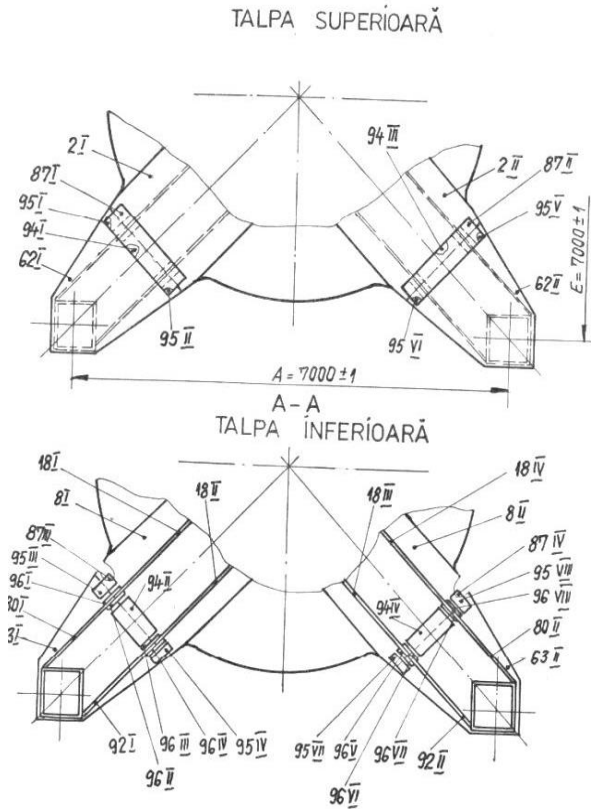
(picture 2), serious welding findings were detected, picture 3.

Fig. 3. Upper sole and lower sole – tripod

In order to repair these defects, a press fitting will be performed under the bottom plate.

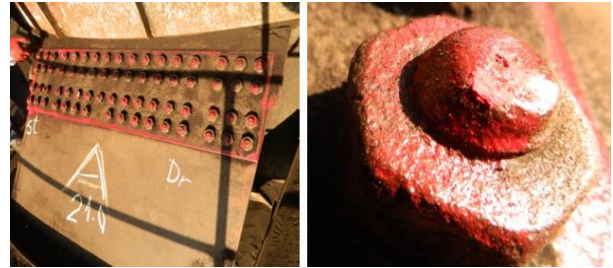
Picture 5 - face support - upper sole.

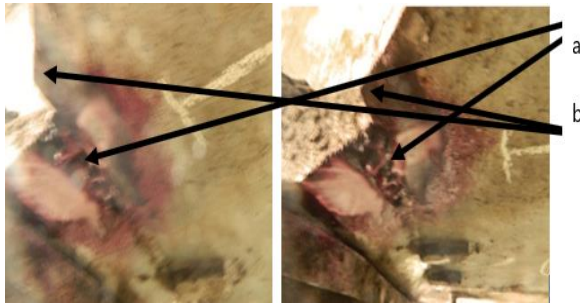
Fig. 4. Defect plate-position 6 (S45 and S46)

At welded plate - position 6, S45, S46 (picture 3) serious weld defects were detected, figure 4. Here you will urgently intervene to restore the weld. After welding, the corners a and b (fig.4) will be polished to the left and right with a certain radius. At the front bearing (A top plate - picture 5) the clamping screws were checked and it was found that all of this and the glazing are severely affected by rust and abrasive wear. The screws and plate were painted red but it is possible

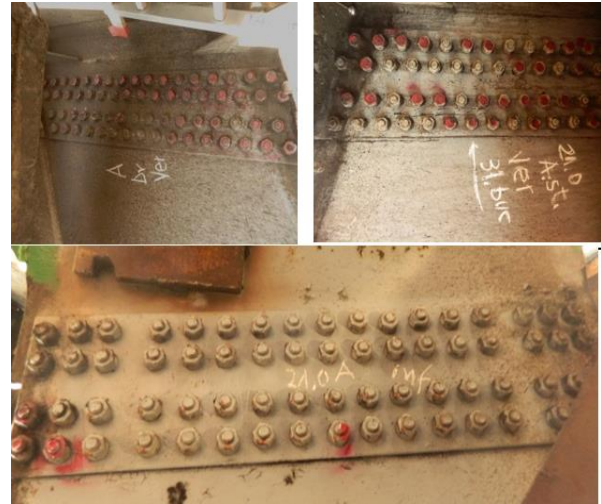
At the side walls and the base plate (fig. 6), the screws have lengths that do not come out of the nut 1.5-2 turns or are weakened, this being determined by testing by transverse impulse on the axis of the screw with the hammer and the answer ball. On each wall are about 25-30 pieces to be replaced.

Picture 6. Side walls and base plate

After replacement, all screws will be tested with the torque wrench. Also, it will adjust the corners of the boards that exceed the slabs and will remove the welds and plates on the welded CM without the technical logic and which do much damage to the structure.

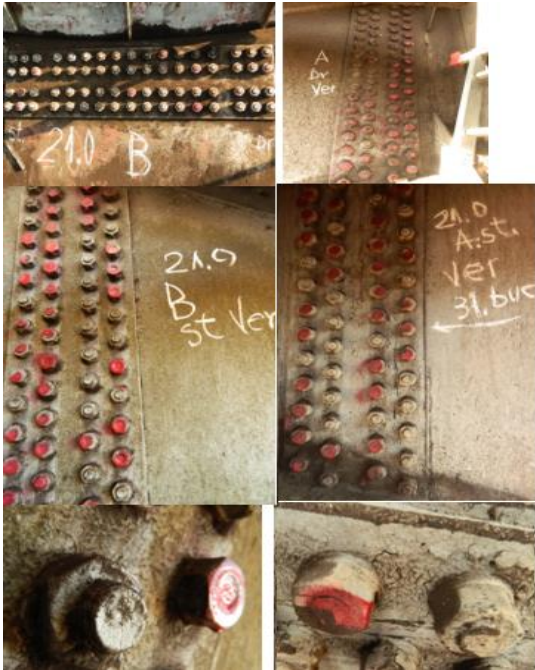
beam) and the supports in points "A" and "B" were checked on the coal side of the deposit, the screws being subjected to impulse vibration testing.

After the control it was found that most of the screws are short (the screws have lengths that do not come out of the nut 1.5-2 turns) they have been painted red and need to be replaced.

Picture 7. Checking the screws used in the connection between the support skeleton and the tripod supports

The IP (IR) screws on all the sub-assembly joints were tested according to the procedure. From the last detail photos are observed, more clearly how short they are and do not correspond to the mounting regulation C 133.

The replacement will be carried out step by step, by replacing each screw and tightening up to 100% (with the passage through 70%, the break and then 85%, pause and finally 100%). It will not be passed to the next screw until the primary corrosion protection will be carried out by priming, testing at 1.1 Mtn and final corrosion protection (painting).
