REHABILITATION OF HELICAL ASSEMBLY (WHEEL BRACKET CUP HOLDER)

COAL EXTRACTION MACHINE M4A Part I

ABSTRACT: In this paper we present the technical state in which is found the helical assembly of a coal suction machine, following the technical expertise. The rehabilitation to which the helical assembly will be subjected will be done through the execution of the intervention works that will restore to the normal operating parameters of both the structural part and the functional part. The paper presents: the modalities of verification of the mechanism as well as the proposed technical solutions for the repair of the assembly.

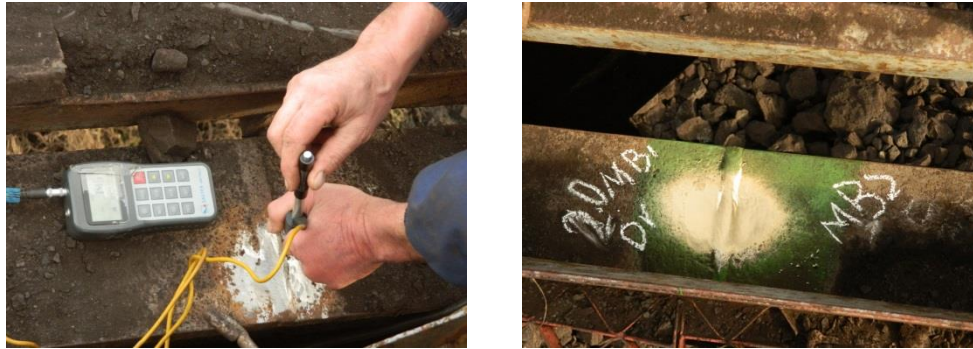
Fig.4 P33-P34 welded joints

The hardness test between P33 - P34 on the side with the main rod (upper right), during the test and at the end.

The hardnesses for the welded joint P33-P34 type end-to-end are the normal ones, with a correctly executed weld having as basic materials those inscribed in the basic documentation. The control with Lp and Us did not show defects that did not respect the quality class. P22-P15 welded

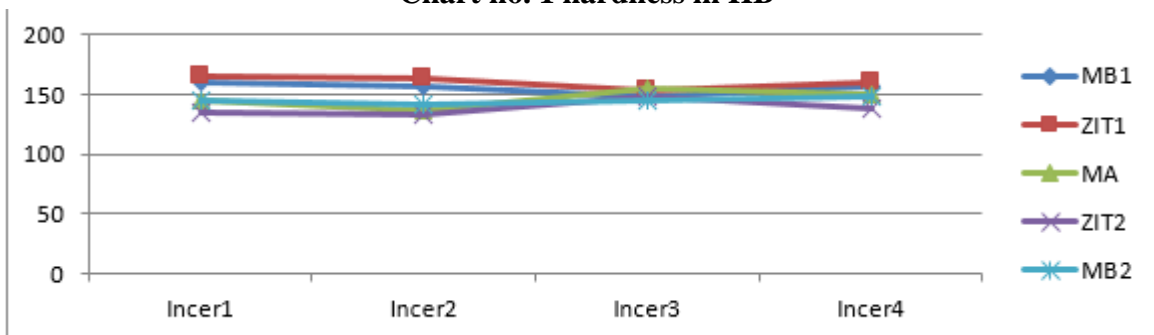
Chart no. 1 hardness in HB

Head weld between P33 and P34 upper right leg. Hardness [HB]		MB1	ZIT 1	MA	ZIT 2	MB 2
1	1	160	165	145	135	145
2	2	156	163	137	133	142
3	3	149	154	155	148	145
4	4	156	160	150	138	149

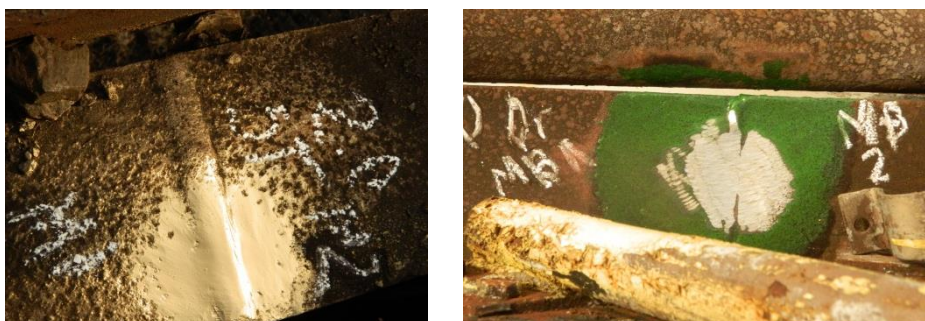
Fig.5 P22-P15 welded joints

Hardness test between P22 - P15 on the side with the main rod (upper right), during the test and at the end.

joint hardening types are the normal ones, with a properly executed weld. The control with Lp and Us did not show defects that did not respect the quality class.

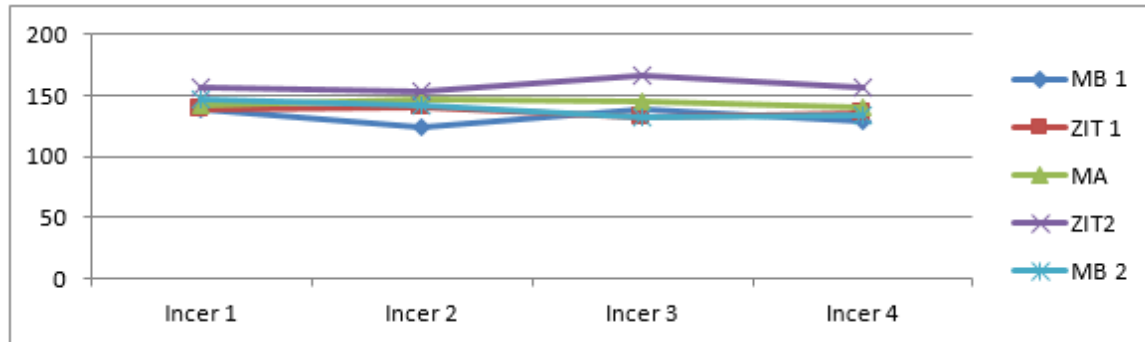
Chart no.2 of hardness in HB

Sudura Cap la cap		MB1	ZIT 1	MA	ZIT 2	MB 2
intre P22 si P15 grina dreapta palpa superioara. Duritati [HB]	1	144	158	120	133	133
	2	150	142	125	124	132
	3	161	147	156	116	128
	4	144	152	143	119	121
