REHABILITATION OF HELICAL ASSEMBLY (WHEEL BRACKET CUP HOLDER) COAL EXTRACTION MACHINE M4A Part II

ABSTRACT: In this paper we present the technical state in which is found the helical assembly of a coal suction machine, following the technical expertise. The rehabilitation to which the helical assembly will be subjected will be done through the execution of the intervention works that will restore to the normal operating parameters of both the structural part and the functional part. The paper presents: the modalities of verification of the mechanism as well as the proposed technical solutions for the repair of the assembly.

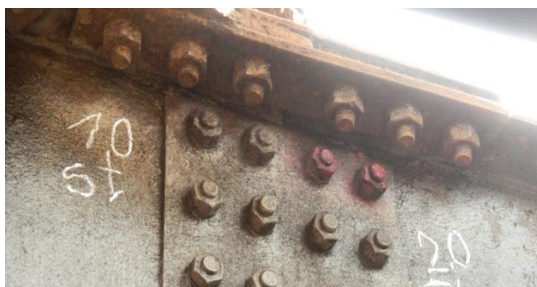
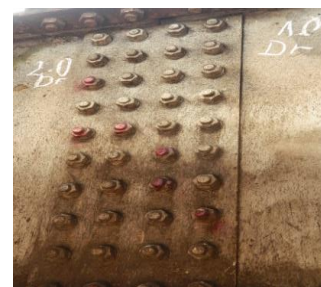
The connections with IP screws (IR) between Section I (the part that is bolted on the rotating platform) and Section II (the part that is attached to the Tiant I)

respectively from sketch no. 1 and sketch no. 2 are non-conformities that we are presenting below.

Fig.1 Screw connections

The screws that at the impulse and vibration test have oscillations that denote that there has been weakening of the assembly are painted in red. On the upper soles in both beams (left and right) The ecclesiastics were deformed due to the appearance of rust between the ecclesia and

the sole of the beam on both the upper and lower ones. At repair, the node will be dismantled and depending on the degradation it will be decided eventually to replace the strap, but it may even replace a portion of the sole of the beam.

The screws will be replaced at the opening of the church. The connections with IP screws (IR) between the Section II and the Support of the wheel-cup

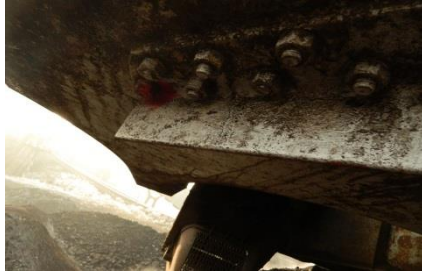
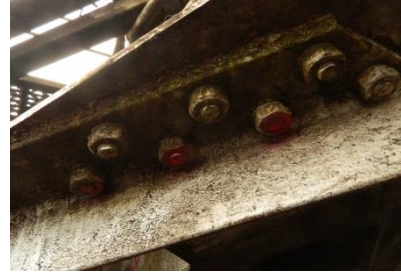
Fig.2 The Catching from the section X2-X2

The clamping in section X2-X2 of sketch no.3 is from corners placed in x, it has

screws that vibrate at the impulse test, or painted in red.

mechanism presents at the joints with deficient screws that will have to be removed at a future repair.

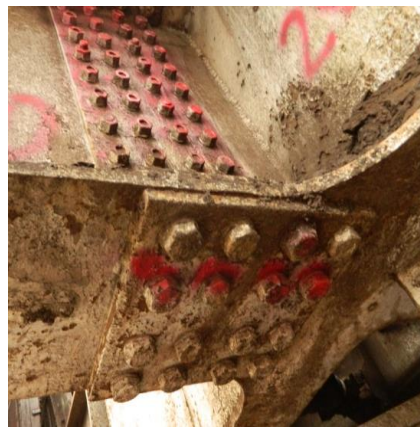
Fig.3 The Catching from the section X1-X1

The clamping from section X1-X1 of sketch no.3 has screws that vibrate at the impulse sample, or painted in red on both the vertical middle of the beam and on its soles.

There are short screws that do not meet the requirements of C 133, these will be replaced with screws corresponding in length, or painted in red.

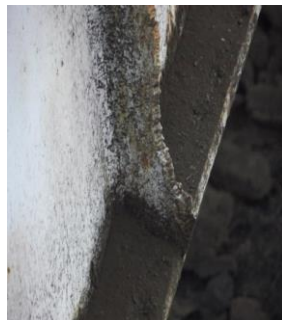
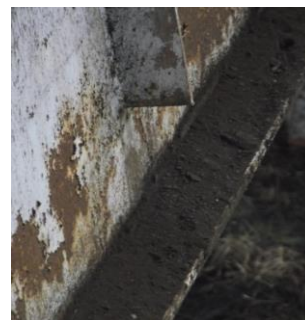
Fig.4 Lateral nerves of the main beam

Lateral nerves of the main beam from "Section II" partially missing (on the st.) From fabrication or uncut for installation, for unknown causes, they will be

executed and welded instead of the ones presented (they are not painted because they are without access to respect the safety at work).

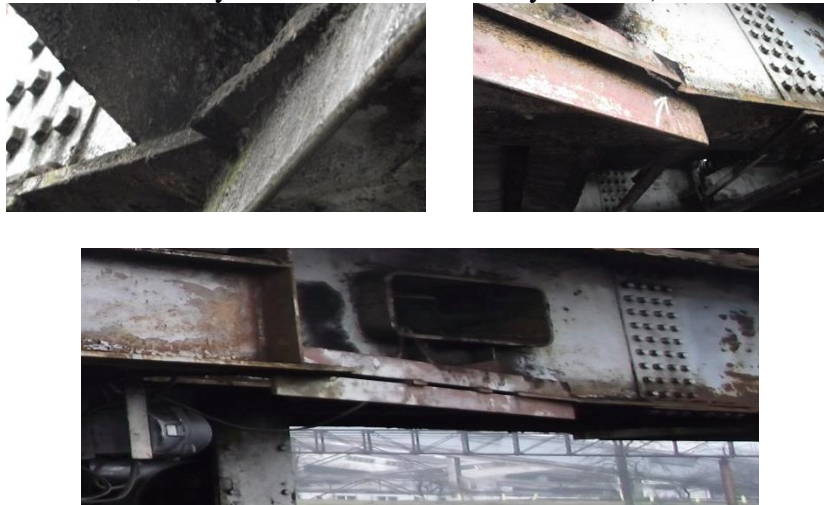
Fig.5. Lateral diagonals from "Section I" with unadjusted parts at lower sole grip

The same deficiency is found on the left side.

They will be adjusted according to the rules imposed in the connections with pre-tensioned screws (Order C 133).

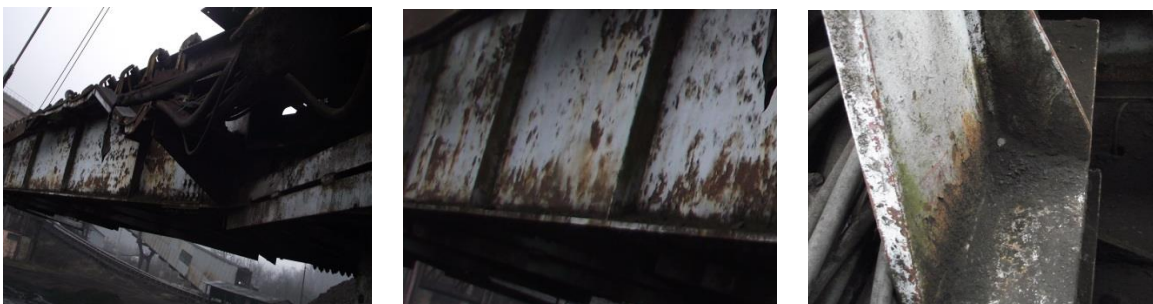
Fig.6 a. Welded joints with rust

Corners with the intersection of sheets that are almost impossible to clean with metallic gloss ((cleaning can be done in a specialized factory) but not in site conditions, which will probably be arranged at the end of the coal deposit for crushing, a place where sandblasting it

The places are generally from the lower sole of the beams at the intersection with its middle and especially where there are various reinforcement boxes, but also at the ear of the mast (the anchor pole of the main tie) on the elinda .

be removed by hammering with a suitable hammer, and similar to removing the slag from electric welding with coated electrode, followed by paint protection "3 in 1" which has the ability to inhibit and stop rusting of the surface on which it is applied. The anticorrosive protection of these areas will be done with the brush in 1-3 layers with the final coating on a thickness of 240- 290 μm dry layer of paint.

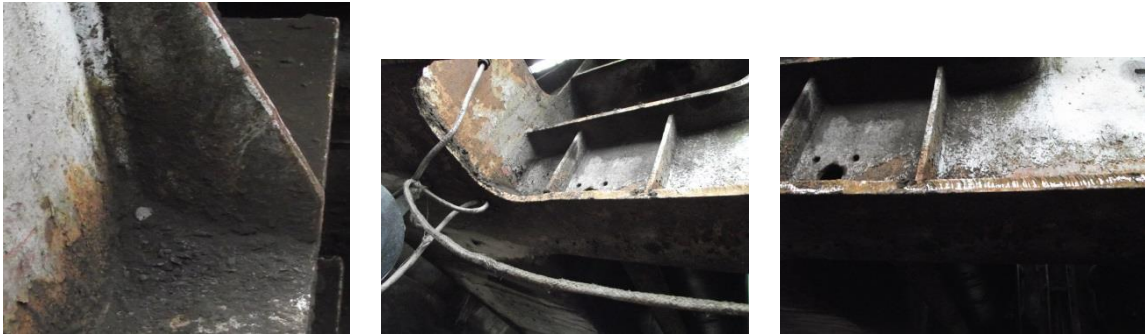
Fig.6 b. Welded joints with rust
