TECHNICAL INSPECTION FOR PATH OF ROLLING FROM COAL REMOVAL MACHINE

ABSTRACT: This way of rolling is carried out on longitudinal ties of reinforced concrete and is formed from the superstructure fixed on the metal plate indirect attachment. Periodic and systematic cleaning of the longrins and rails at least once every 6 months in order to be visible any degradation and to reduce the stagnation of coal dust with sulfur content and which in combination with water leads to the presence of hydrogen sulfide which is highly corrosive.

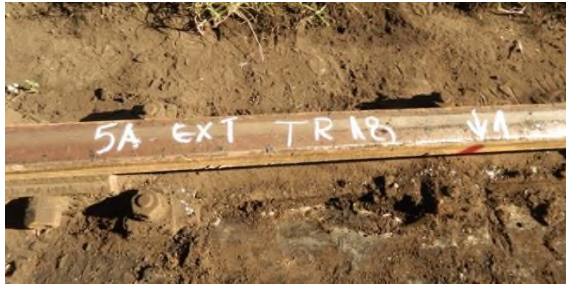
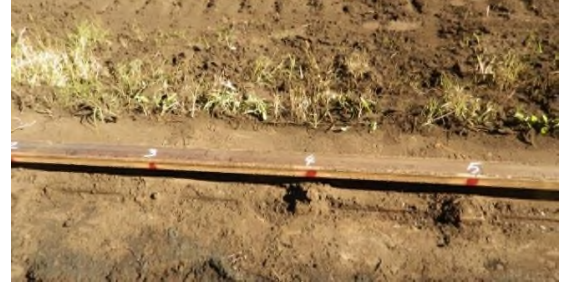
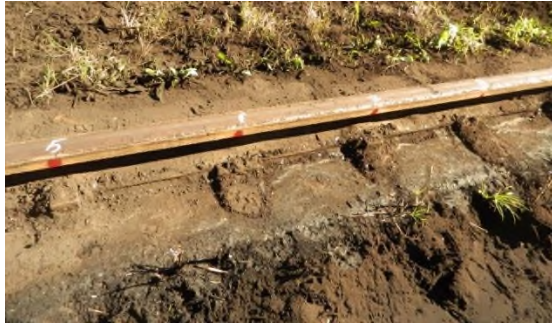
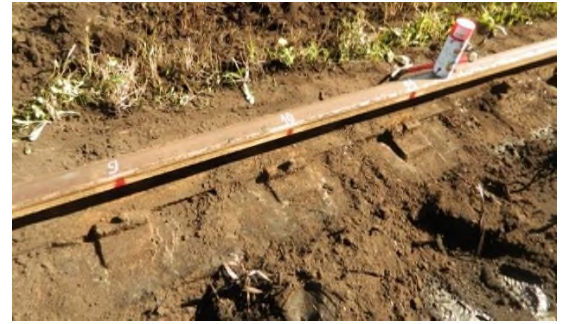
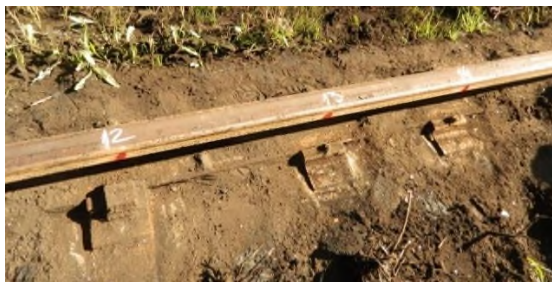
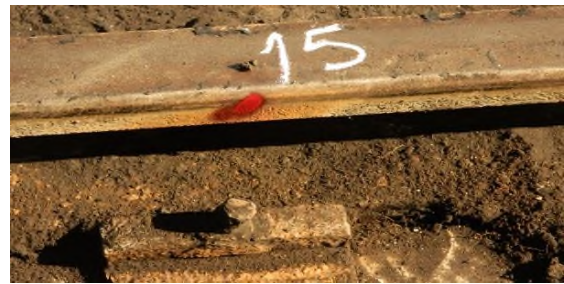
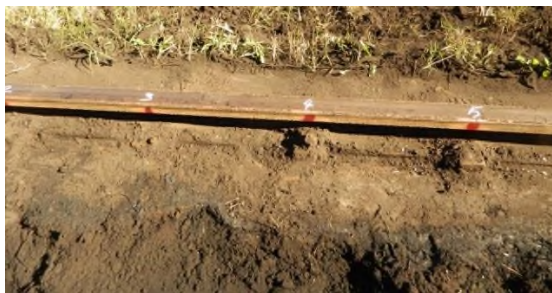
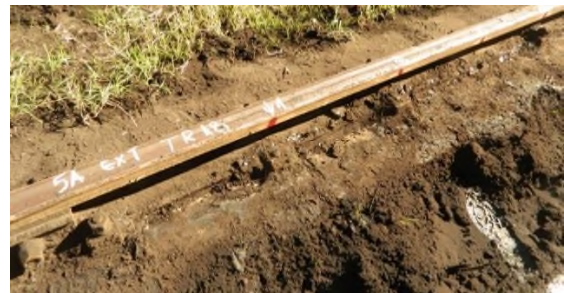
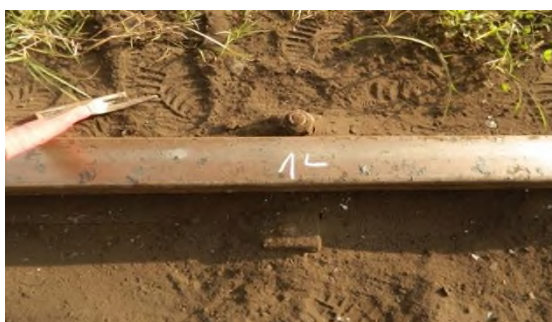
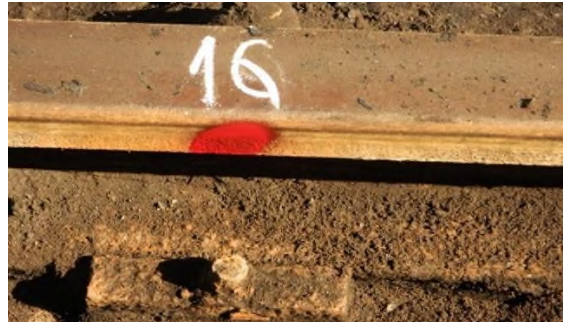
On the outer wire at section 18 there are 16 missing and deformed screws, all the fastening screws on the rail of the rail

(Fig. 1-10). On the rail with these shortcomings. The red paint was signed as can be seen in the photos.

Remedies with "ZERO" emergency degree: During the inspection of the running track of the M5A machine (conveyor T14 A), the M22 bolts, clamps and spring washers were fixed and mounted on the seat plates on the longrina at section 18 where 16 were missing. screws, which are shown in the following photos.

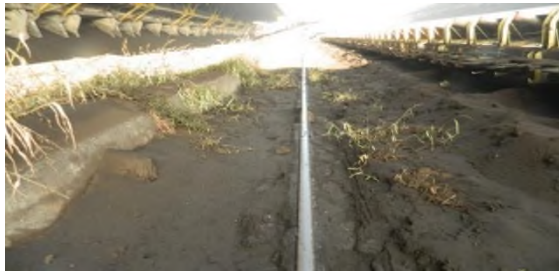
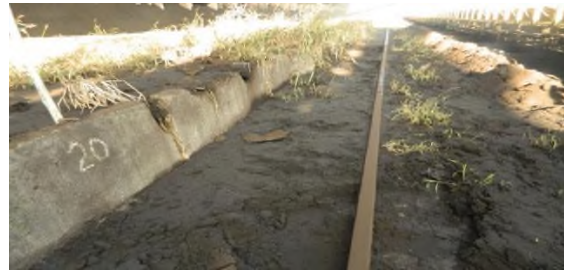
- ✓ the rails are fixed on metal plates type 49 on concrete beams;
- ✓ the inclination of the rails respects the inclination within the allowed limits;
- ✓ in the working area of the M5A machine, starting from the junction 2-3, the heads appeared at the upper part of the rail mushroom;
- ✓ on the side from the unloading footbridge on the longrina and in its vicinity coal dust deposits have accumulated and the rainwater drainage channel is clogged;
- ✓ on the concrete longrina it has a lot of coal dust and in it it has direct contact on 115-120 mm from 135 mm of the CF 49 high rail;

- Replacement of bolts from joints that are deformed, weakened, with missing washers and damaged by rust;
- Periodic and systematic cleaning of the longrins and rails (See fig. 11-12) at least once every 6 months in order to be visible possible degradations and to reduce the stagnation of coal dust with sulfur content and which in combination with water leads to the presence of hydrogen sulfide which is highly corrosive;
