TECHNICAL EXPERTISE OF THE WHEEL'S ARM - COAL EXTRACTION MACHINE - T2052

ABSTRACT: In this paper presents the technical condition of the wheel arm on which the cups are fixed from coal extraction machine T2052, following the technical expertise. The rehabilitation to which the metal beam lifting-lowering mechanism will be subjected will be done by executing the intervention works which will bring back to the normal operating parameters both the structural part and the functional part. The paper presents: the verification methods of the subassembly as well as the proposed technical solutions for its repair.

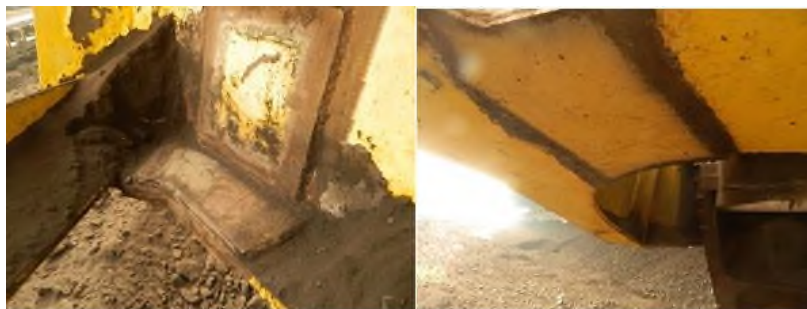
Figure 3. Part break - position 2.

One of the first nonconformities encountered at the position 2 (see figure 1),

was the rupture of the soleplate and the heart of the support due to the twisted position of

the wheel arm when the weight of the wheel and the weight of the actuator has an axial force component that is supported only by it, figure 3.

The metal beam is twisted as a result of the overload, the rupture of section III appeared due to the axial force.

Mandatory will have to be redone in conditions support, support and taking over tasks.

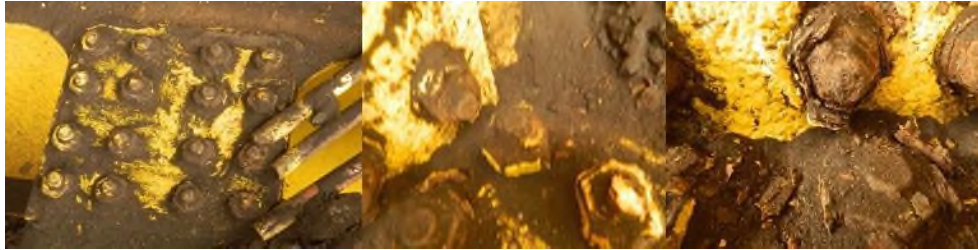
It was found that the screws in the joint between section III and section II are degraded, on the two soles, figure 4.

Figure 4. Wear of the screws in the joint area of section II with section III.

It is recommended to replace the screws on the lower sole during the repair.

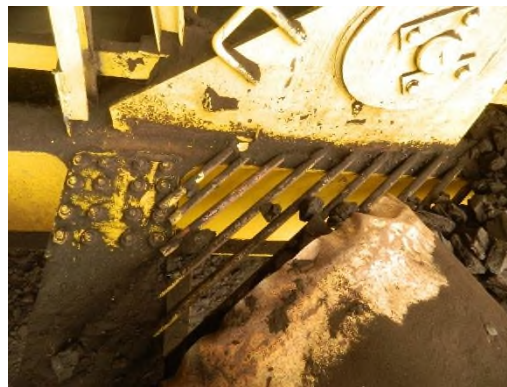
It was found that, in the absence of the walkway, some bars were welded by the two sections II and III, these led to the appearance of slag, coal deposition fact which was

followed by a degradation of both soleplates as well as the gripping ears of the tie rod, figure 5.

Figure 5. Improvisation walkway

Here it is recommended to repair the entire area regarding the access road and the walkway according to the initial documentation.
