## TECHNICAL EXPERTISE OF THE ROTARY PLATFORM - ASSEMBLY OF THE COAL EXTRACTION MACHINE - T2052

**ABSTRACT:** In this paper presents the technical condition of the rotating platform for coal extraction machine- T2052 , following the technical expertise. The rehabilitation to which the “rotating platform” assembly will be subjected will be done by executing the intervention works that will bring back to the normal operating parameters both the structural part and the functional part. The paper presents the verification methods of the assembly as well as the proposed technical solutions for its repair.

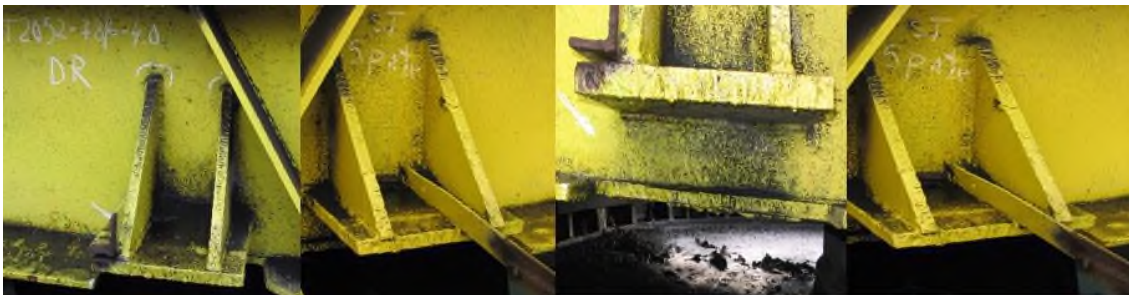
The supports for lifting the superstructure in order to replace or check the bearing were welded on the platform's mantle and it was debited impermissibly from the platform sole in all four corners of the platform, this being highlighted in the photos in fig.1.

Figure 2. Nonconformities in marked areas.

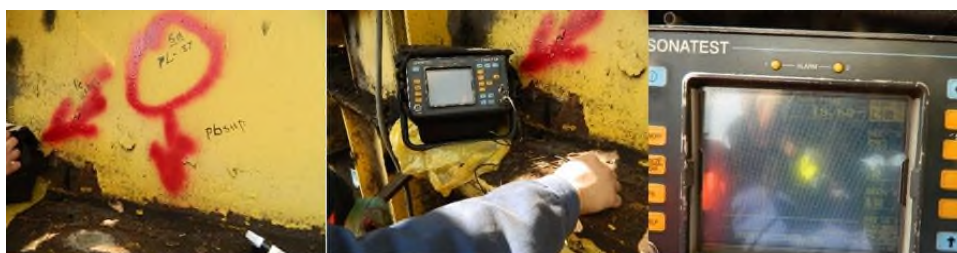
Figure 3. Wear of the screws in the joint area of section II with section III.

Following the measurements performed at the metal construction where the thickness of the material was according to the documentation of 20mm, there was found an uneven degradation up to 18.6 mm, of 7% by oxidation, which is above the limit of 5% appreciated as admitted at mining equipment for taking over coal warehouses (the influence being due to the presence of sulfur), figure 2.

As a rehabilitation proposal, it is imposed to cladding to hardening the metal

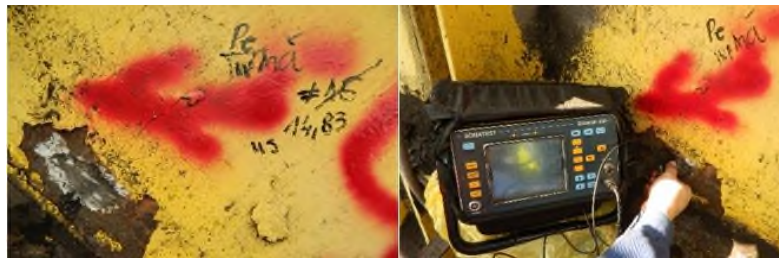
construction in degraded areas. An ultrasound control was also done on the jointing heart between the platform and the balancing arm. Here was found non-uniform a degradation from 16 mm to 14.83 mm, which means a process of oxidation of the material of 7.32% by oxidation, this percentage being above the allowed limit of 5%, figure 3.

Figure 3. Material thickness control at the joint core between the platform and the balancing arm.

The measurement included only the strongly affected area in the accumulation area of coal dust which is containing sulfur and in dampness conditions, ensue a weak mixture of hydrogen sulfide, a strong oxidizer of steel. Another non-conformity was found following the control of the prestressed screws in gr. 8.8 and 10.9. This shows that a part of the screws no longer ensures a tightening to ensure the correct joining of the eclipse between the platform and the balancing arm, fig.4. Here it is recommended to tighten and / or them replacement as urgent.

And here, as in the previous case, the cladding was imposed to strengthening the metal construction in the degraded areas.

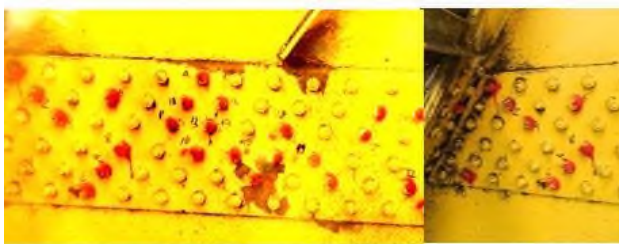
Figure 4. Screw control on the platform sole

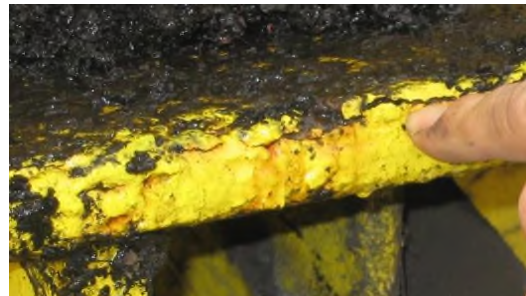
Welds were performed on the upper sole - this being strongly corroded. Adjustment and plating for stiffening are recommended.

Figure 6. Nonconformities - lower sole

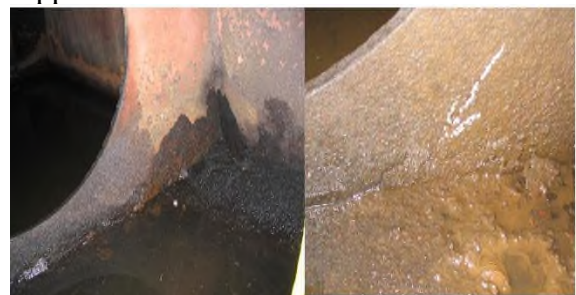
Strong corrosion of the platform inside, in the area of the right bearing-fig.7. The presence of water is observed,

Figure 7. Corrosion inside the platform  
Crack in the resistance metal construction, fig.8. Urgent remediation by specific technologies is needed. Here a great care must be to the welding temperature, the admixture materials and the qualification of the welders.

It is recommended to clean and remaking the anticorrosive protection. It will be practiced stiffened drain bores and drain nipples.

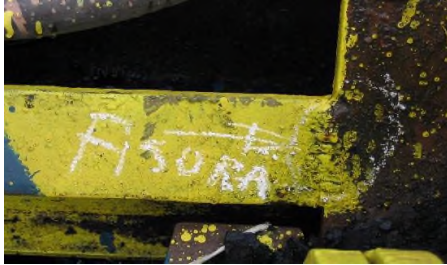
Figure 8. Nonconformities - strength metal construction

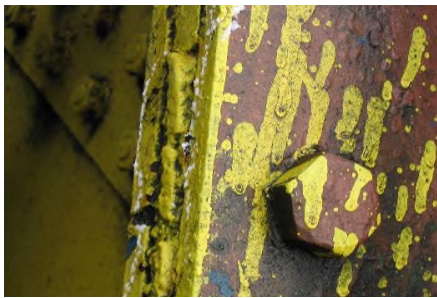
Oxy-gas adjustment of the eclipses in the joint with IR screws and strong corrosion of the joint.

Fig. 9. Ecclesiastical nonconformities

Urgent remediation through specific technologies is needed.
