THE EXPERTISE OF THE ENSEMBLE „THE METAL BEAM - SECTION II"- COAL EXTRACTION MACHINE - T2052

ABSTRACT: In this paper presents the technical condition in which it is found the metal beam - section II, from the T2052 coal extraction machine, following the performing technical expertise. The rehabilitation to which the metal beam - section II assembly will be subjected will be done by executing the intervention works that will bring back to the normal operating parameters both the structural part and the functional part. In the paper are shown: the verification methods of the assembly as well as the proposed technical solutions for its repair.

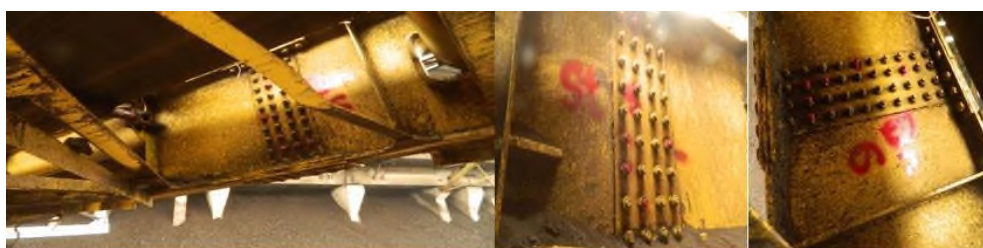
At the joint between the sections it was found that the screws are loose, they are

shown in figure 3, where it can be seen that the screws with defects are marked with red paint. It is recommended, in this case, to tighten or replace them if necessary

Figure 3. Non-conformities regarding the tightening screws.

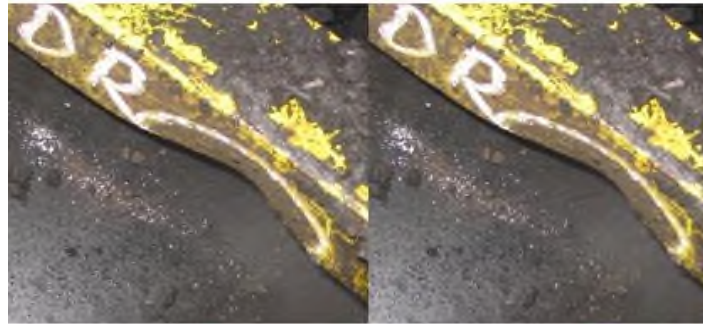
Diagonals of resistance (denoted DR), from the metal construction of the wheel's arm, are deformed, figure 4.

Figure 4. Diagonals of resistance

Important to remember that it is necessary to unload the effort because the metal construction is twisted due to overloads. The diagonal will be replaced when the superstructure is mounted when replacing the eling joint.

It is recommended, after unloading of voltage of the construction, to replace them.

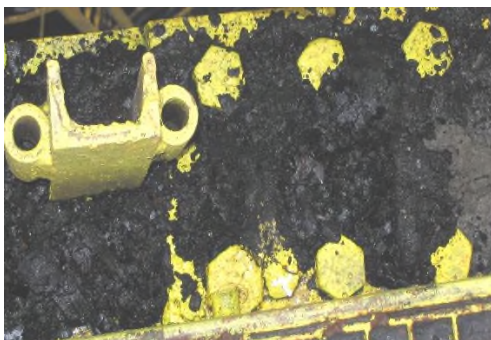
On the right side, near the joining eclipse between section I and section II, metal constructions were improperly welded, without having a functional role, fig.5.

Figure 5. Improper welding of metal structures.

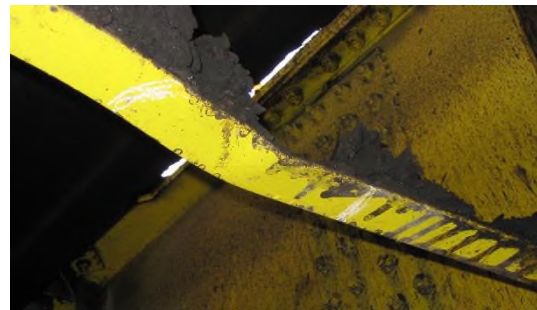
The transverse beam, see position 41 of figure 2, in the lower field, in the joint area between section I and section II, (on section I) is bent, figure 7. It is recommended to replace it urgently.

Figure 7. Non-compliance - transverse beam

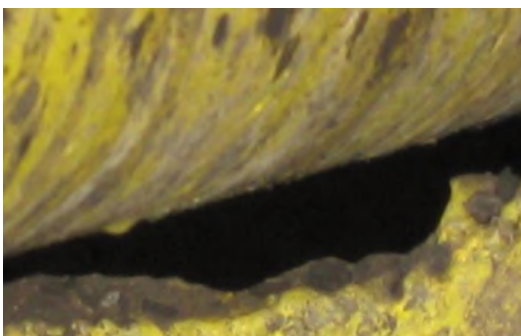
The diagonal, see pos.157 of figure 1, was debited oxygas, irregular when mounting the roller support, figure 5. It is recommended to disassemble the support of roller and correct reassembly, polishing and strengthening the diagonal or replacing it.

Fig.6. Non-conformities with respect to the diagonal given by heading 157.

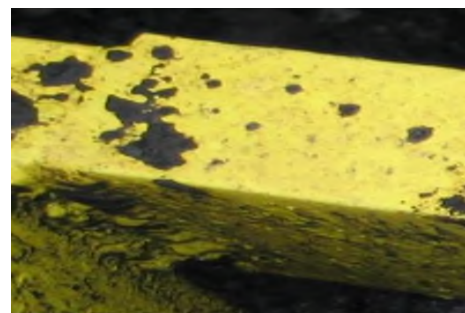
Figure 8. Non-conformity - diagonal in the lower field

A diagonal in the lower field was cut for unknown reasons and was again improperly welded, figure 8. Repair is required with unloading and supporting the metal beam.

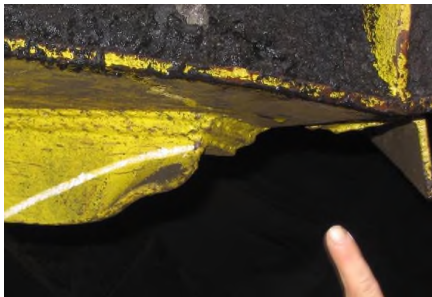
The soleplate in the lower field has been cut for unknown reasons, it will have to be adjusted during the repair, figure 9.

Figure 9. Non-conformities - the soleplate of the lower area.

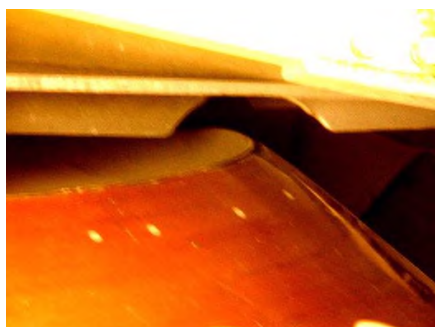
Fig.10. Non-conformities - the soleplate of the upper area.

The soleplate in the upper field was debited due to the torsion of the construction of section II, figure 10. It is recommended that it be adjusted during repair. When repairing, after straightening the section, it will be completed trimmed area.
