EXTENDED TECHNICAL INSPECTION OF THE INCLINED ARM OF THE M5A COAL REMOVER

1. INTRODUCTION. TILTED ARM OF THE M5A COAL REMOVER

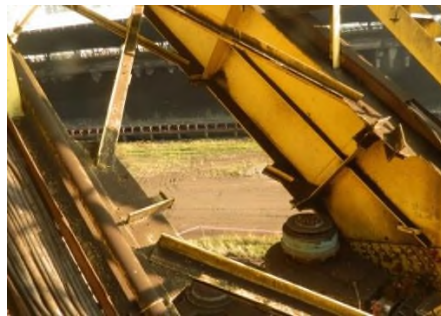
Fig.2

Unpermitted flows on the metal construction in the area of the rotation actuation mechanism, fig.2.

Pos.11, 14, 15, 18, 21, 22 from section. A-A debit. Careful! - must be urgently reassembled according to the

documentation. Imminent danger of major construction damage.

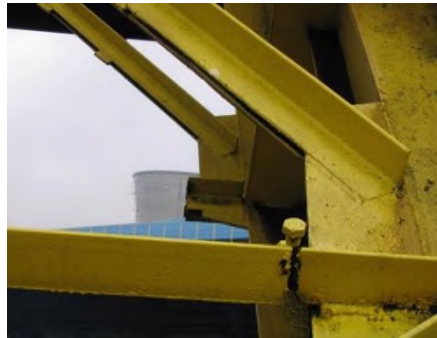
Fig. 7

The transverse upper bracing between pos.24 left-right cut and reassembled improperly, fig.7. Attention - urgently

needs to be reassembled according to the documentation. Imminent danger of major technical accident.

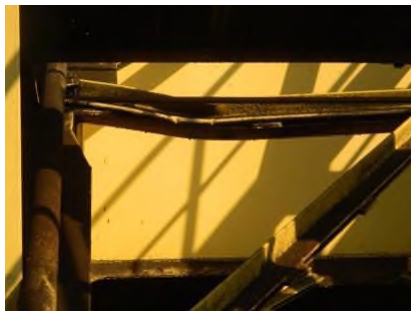
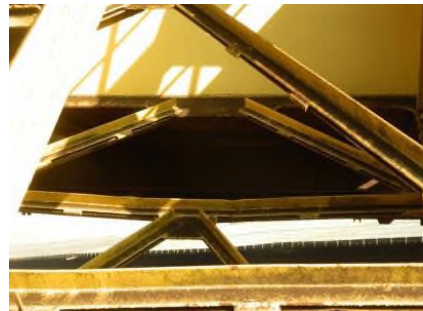
The bracing pos .17 and the transverse room pos.13 shown in fig.8 and fig.9 are

deformed. They will be replaced during the repair with the discharge of efforts.

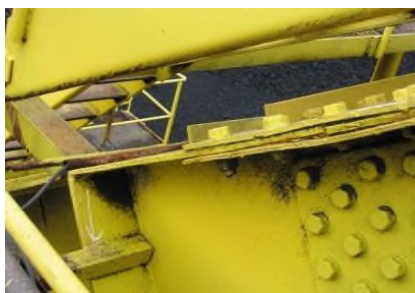
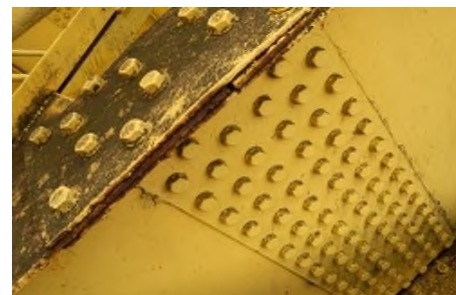
Joining details between the support of the lifting mechanism and the inclined arm, in 2003 the beginning of the degradation reached now in an accentuated state when

it is necessary to replace the eclipses with the restoration of the area. They will be replaced during the repair with the discharge of efforts.

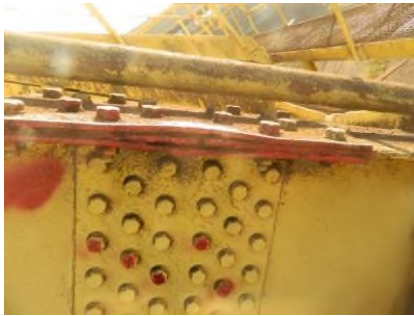
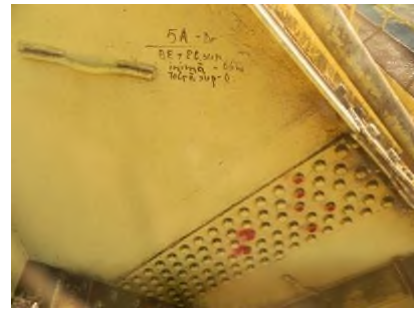
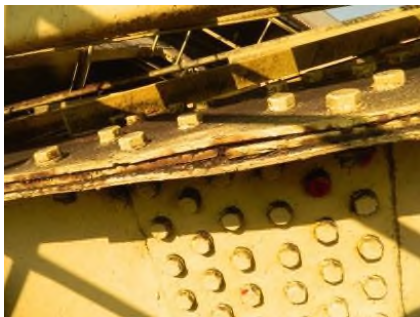
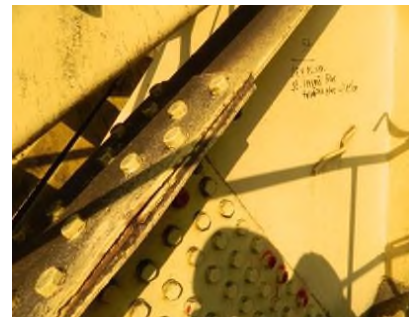
The control of the screws by the vibration method indicated that there are defects and the eclipses on the upper soles and the screws will be replaced urgently.

The deformations reach 8-11 mm by removing the sole in the median areas, fig.12-15.

They will be replaced during the repair with the discharge of efforts.

Unloading requires support on the scaffolding under the beams of the ballast box and lifting on presses 150-175 mm.
