Effects of acidic water containing tailings on the insulation of electrical cables

ABSTRACT : In this work are analyzed the causes of failure of the electrical power cables laid in areas with high pollution level. The research was mainly aimed at identifying the effects of acidic water with sterile content on the insulation of electrical cables with low natural aging degree (recently pictured) and analyzing the results of the pH measurements of the water samples in the vicinity of the cable routes, harvested during the performance of the defectoscopy operations, in three different areas. The case presentation describes in detail the stages of prelocation and location of the fault at a medium voltage cable posed in the "Saint Helena" Wind Park in Coronin, jud. Caras-Severin, an area where the measured pH values recorded the highest acidity content in the soil water. The cable broke down as a result of the penetration of the polymeric insulation next to the shrinkable sleeve, caused by contact with acidic water containing sterile.

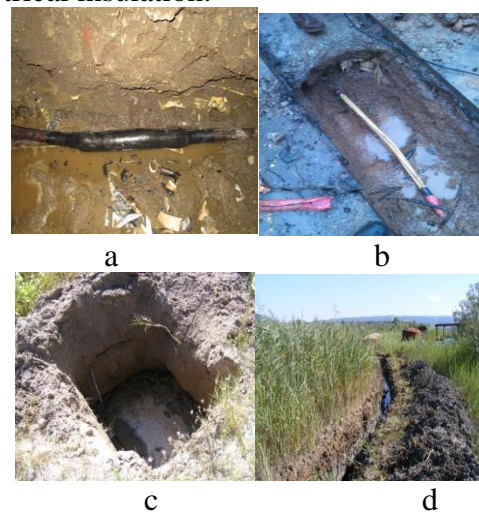
Figure 1. Areas with high humidity in the vicinity of cable routes: a) Zona Lugoș (driveway pedestrian on the shore Timișului); b) Zona Reșița (Ateneu); c) Area

Platoul Coronin (Parc Eolian ” Sfânta Elena”);

d) Area Moldova Nouă (Estacadă - Insula Ostrov)

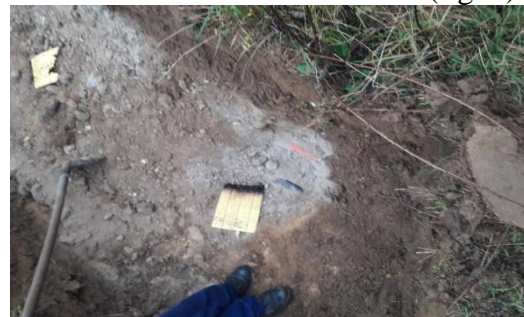
In the first phase, the earth was mechanized to the warning film arranged over the cable when laying, and it was noted the existence of a white dust (sterile sand) in the composition of the soil above the cable route (fig. 2).

Figure 2 . Identification at the site of the defect of a layer of sterile sand (white) that was also observed along the cable path in the stripped portion

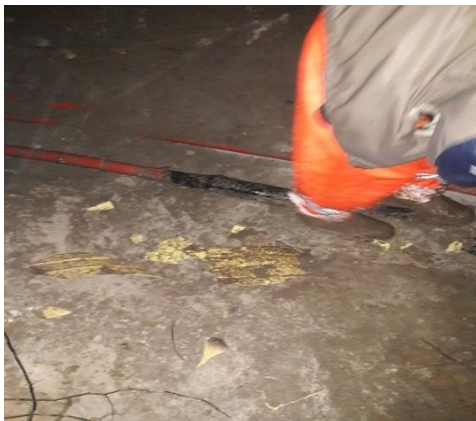
In the second phase, in order to avoid hitting or breaking the cable circuits with the excavator's bucket, the earth was removed manually until the defect was viewed with the naked eye. It was observed that the sterile substance resulting from the mixture with the water on the defect portion solidified, probably as a result of temperature differences, comprising in its structure all three cable circuits. This state exerted a pressure (mechanical stress) on the insulation and limited the temperature exchange of the cable circuits with the medium (Fig. 3).

Figura 3. Identificarea defectului de manșon pe porțiunea cu steril solidificat

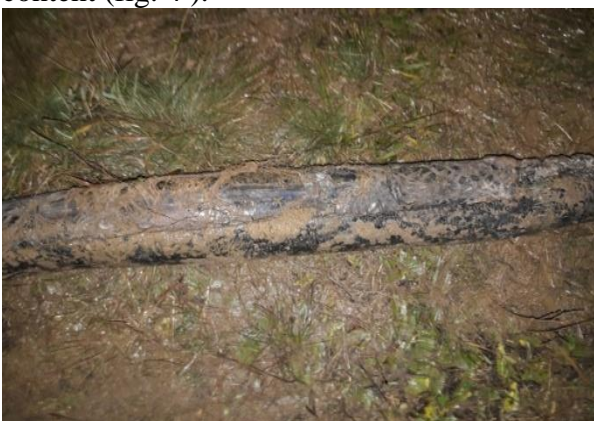
The defect was identified in a shrinkable sleeve whose insulation was effectively destroyed, becoming a gelatinous mass as a result of the acidic effect of water with sterile content (fig. 4).

Figure 4. The place of penetration of the shrinkable sleeve as a result of the degradation of the external insulation

- The case presentation highlights the aggressive action of the acidic substance with sterile content on the polymeric insulation of the shrinkable sleeve that effectively caused the transformation of the insulating layer into a gelatinous mass, causing the defect to appear.

The cable was repaired by replacing the sleeve, the sleeve operations being carried

out in conditions of very high humidity and in the reflector light. The area where the sleeve was carried out was protected against the ingress of rainwater by installing a tent for rapid intervention and the solidified tailings portion was removed and replaced with a layer of protective sand (fig.5).

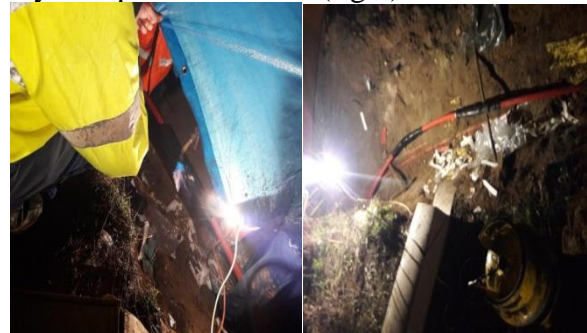
Figure 5. The final stages of repairing the defect: a) The operation of mounting the sleeve in conditions of high humidity ; b) Removal of the tailings from the cable route and laying in the sand of the portion of the cable sleeved
