TECHNICAL EXPERTISE FOR THE ARM ASSEMBLY OF THE CUPS- HOLDER WHEEL FROM COAL EXTRACTION MACHINE

Professor PhD Eng. Marius Liviu CÎRȚÎNĂ
Lecturer PhD Eng. Constanța RĂDULESCU
University „Constantin Brancusi” from Targu-Jiu, ROMANIA
cirtinaliviu@gmail.com, rpc10gj@gmail.com

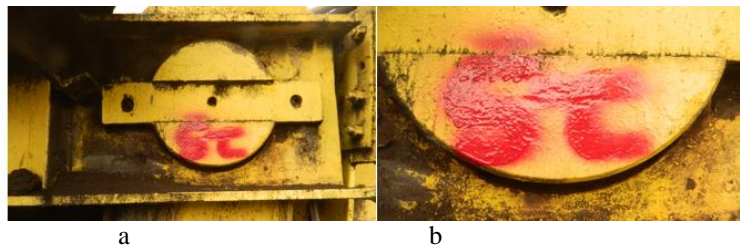
Fig.3. Check the section on the left side, the area of the bolt and the clamping ears.

conveyor, and the balance arm to the access path from the outside of the conveyor or to the interior between the unloading path and the conveyor. On the metal construction (the part circled on the overall drawing, fig.2), fig 3.a, with detail in fig.3.b, a profile was welded to fix an auxiliary construction.

For this area of section I, the necessary rehabilitation work will have to include: ear removal; welding polishing; control with penetrating liquids. It is necessary for the replacement of the 4 clamping ears to be made following a new project, as soon as possible. It is worth mentioning that in this area the wear is between 16-19mm.

It was also found that the safety of fixing the bolt of the hinge joint on the left side is fixed with welding points, which is why the following works are needed for the repair of this subassembly: disassembly of safety; disassembly of the bolt (specific technology), check the bolt, the execution drawing for the manufacture of a new landmark, bolt execution and reassembly according to the documentation.

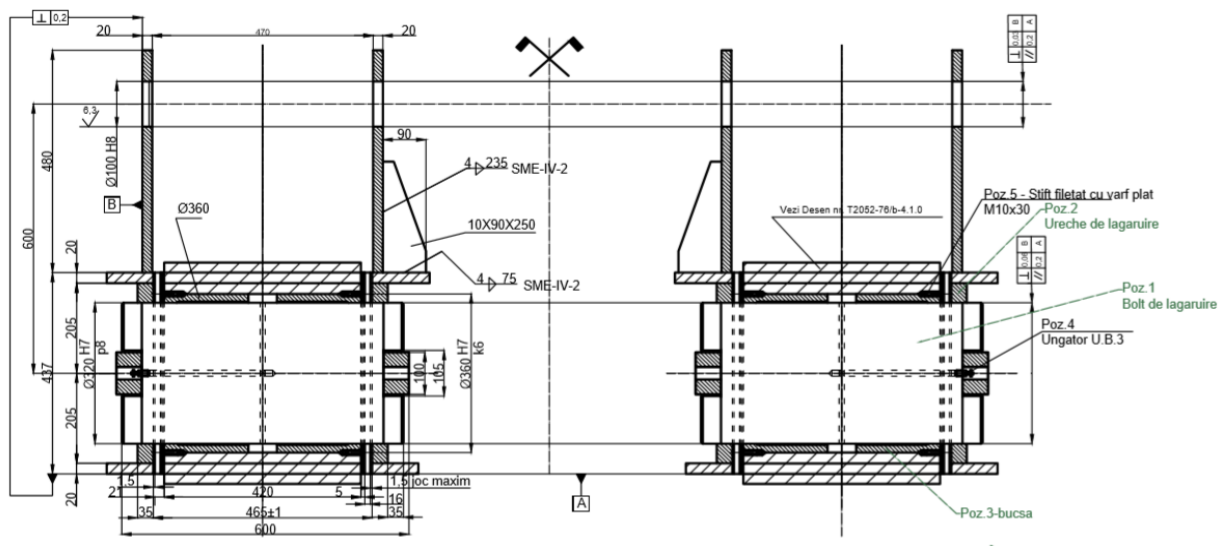
Fig. 4. The subassembly: metal structure-ear-bolt-bush.

A detailed technical presentation of the arm of the cup-holder wheel, section I, is shown in Fig. 4. In addition to the execution drawing of the bolt (pos. 1, fig. 4), they are required the execution drawings for: the catching ear (pos.2, fig.4) and the bushing (pos.3, fig.4).

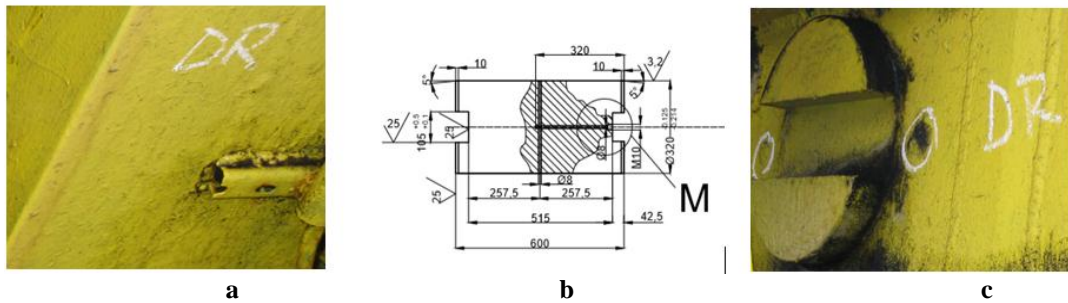
Fig.5. Checking the right area of section I.

On the right side, the locking bolt of the hinge joint is missing, (pos. 75, fig. 1) and the clamping screws are broken into holes, fig. 5, a.

Rehabilitation work required on the right side of the wheel arm will be: disassembly of the bolt (specific technologies and execution drawing, fig.5.b); bolt verification and safety execution; replacement according to documentation. On the metal construction of resistance were welded profiles for the metal garments to support the components of the electrical installation, fig.5 c.

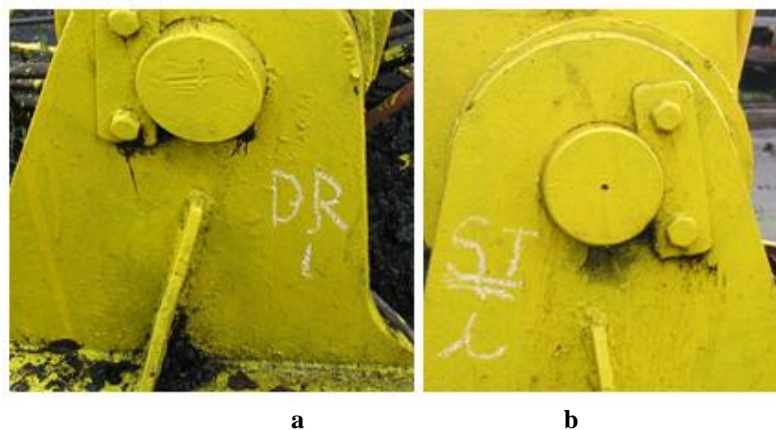
Fig.6. Defects of the clamping ears

The clamping ears (pos. 29, fig.1) on the inside right side, fig.6.a, respectively the inside left, fig.6.b, they have pinches on the outer contour.

It is necessary to grind, on the contour as well as in the welding area on the sole, all four ears after which the welding control is performed.

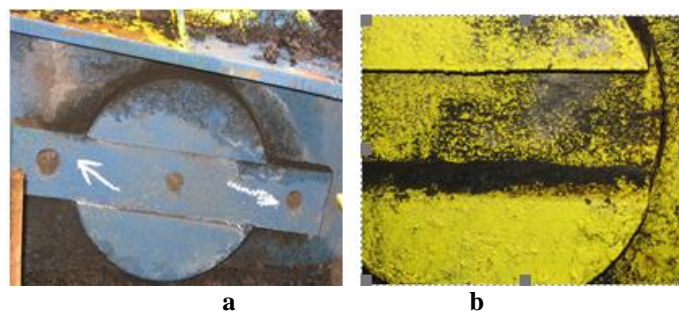
Fig.7. Defects in the safety area of the bolt

At the safety on the bolt (pos. 75, fig1) (right inner wall, fig.7.a and left inner wall, fig.7.b) the fixing screws in the threaded holes are broken and the bolts are locked and to rotate together with the arm of the cup-holder wheel.

Here it is necessary to make a depression of the bolts, machining the bores, enlarging the threaded holes and possibly replacing the bolts if after disassembly it will be found that they are worn. At the heart of the metal construction in the arm of the cup-holder wheel have been practiced holes with oxyacetylene flame, as seen in fig. 8. a, b and c.,in order to be able to draw a conclusion on its state.

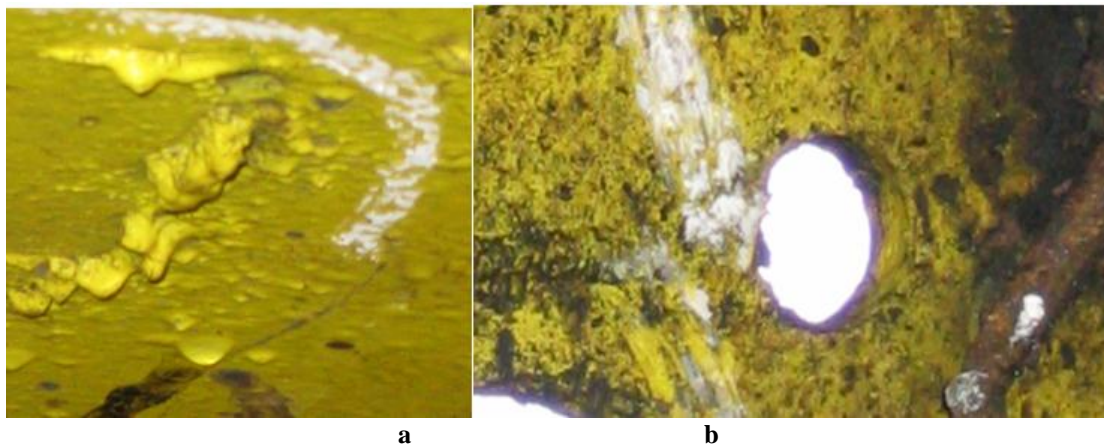
Fig.9. The welding cords made on the lower sole of the arm

On the lower sole of the arm (pos. 16, fig. 1) they were welded metal profiles, currently removed, fig.9. a, and in the bore area on the right side, also welding cords are observed, fig.9.b.

The rehabilitation works required in this area are: removal of the welds by grinding and control with penetrating liquids throughout the affected area. It may be necessary after the control to replace significant portions of the metal construction.
