# ON QUALITY CONTROL OF THE FRONT HOOD MARK

**Abstract:** The object of the study is the, Front Hood Panel a component of the car body. The quality checks on the Front Hood Panel are of two types: visual checks and geometry checks. Solutions are proposed to eliminate defects and improve the quality of the part

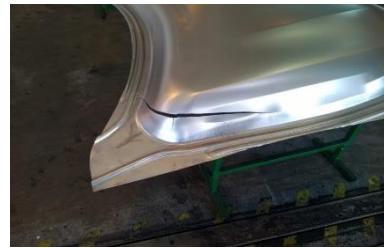
Fig.6. Semi-finished product breaks

Breaks occur due to excessive pulling of the material, i.e. thinning in certain areas. fig. 6 shows a broken blank in the rear area of the hood:

In order to prevent breakage of the semi-finished product, either the size of the joints or the radii (the smaller the radii, the greater the risk of material breakage) are changed. Also, the shape of the beams, fig. 15, placed on the pre-bed has been modified for a uniform pull of the material.

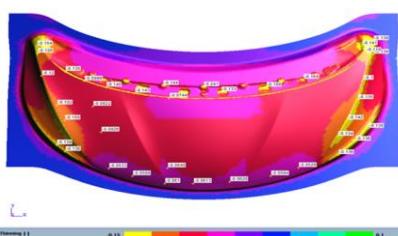
Fig. 12. Material thinning simulation

The verification is carried out by actually measuring the workpiece in areas where there are risks with a special ultrasonic thickness gauge , fig. 13. A special conductive liquid based on glycerine is used, which is applied to the tip of the transducer and the data is obtained. The areas most at risk for thinning are highlighted in the program in yellow, fig. 12.

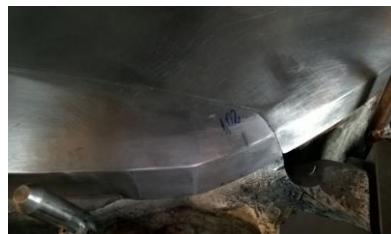
Fig. 16. Counterframe

In order to correct the marks that appeared on the hood at the front, the cause of their appearance was traced. Thus it was found that the visual defects highlighted in fig. 17 were caused by the incorrect attachment of the counterframe to the calliper, fig. 16.:

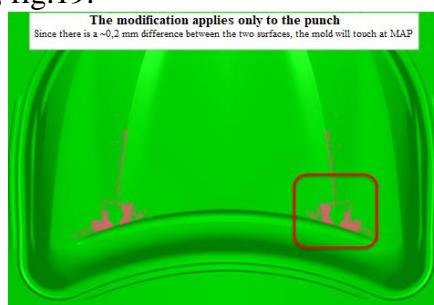
Fig. 18. Overlapping surfaces

It was observed from the simulation that the surface of the ambutised part did not correspond to the 3D numerization received from the customer. So a request was made to the CAD designers in the Fabrication Sheet department to redo the surface of the habillage in that area, fig.18., fig.19.-

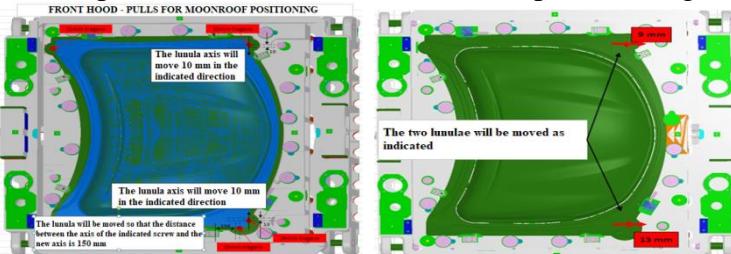
Fig. 23. Changing the position of the lunula

Fig. 22 shows the red line marking the edge of the table in the area of the lunulae to emphasize how far it has gone over the allowable limit. Immediate action was taken to address this defect and it was concluded that the position of the lunulae was out of position , fig. 23.:

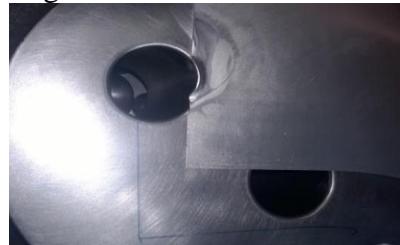
Fig. 24. Current lunula area

After correcting the position of the lunulae, the current situation is much better, as can also be seen in fig.24.
