**MONITORIZAREA SI
DIAGNOZA
COMPORTAMENTULUI
DIVERSELOR TIPURI DE
MOTOARE ELECTRICE DE UZ
INDUSTRIAL FOLOSIND
ANALIZA IMAGINILOR
TERMOGRAFICE**

**MONITORING AND DIAGNOSIS
OF THE BEHAVIOR OF
VARIOUS TYPES OF
INDUSTRIAL USE ELECTRIC
ENGINES USING
THERMOGRAPHIC IMAGE
ANALYSIS**

**Alina DINCA, Vasile COZMA,
Marian IONESCU**

*“Constantin Brancusi” University of
Targu-Jiu, ROMANIA*

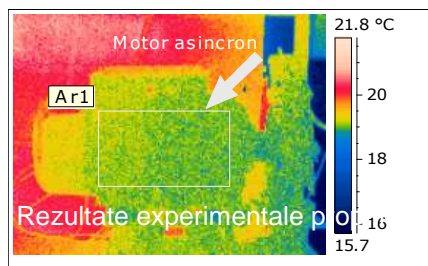
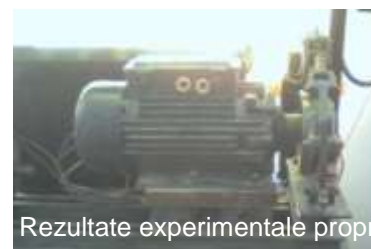
Figura 7.a. Motor in infrarosu la temperatura mediului; b. Motorul in vizibil
Figure 7.a. Electric engine in infrared –environmental. temp; b. Electric engine in visible

In figura 7. de mai jos este imaginea termica a motorului la temperatura mediului ambiant, care contine informatii termice (ex.:temp medie a ariei 19°C), cat si imaginea sa in vizibil:

In figure 7. below is the thermal image of the electric engine at environmental temperature, which contains thermal information (e.g. average temperature in area of 19°C), as its visible:

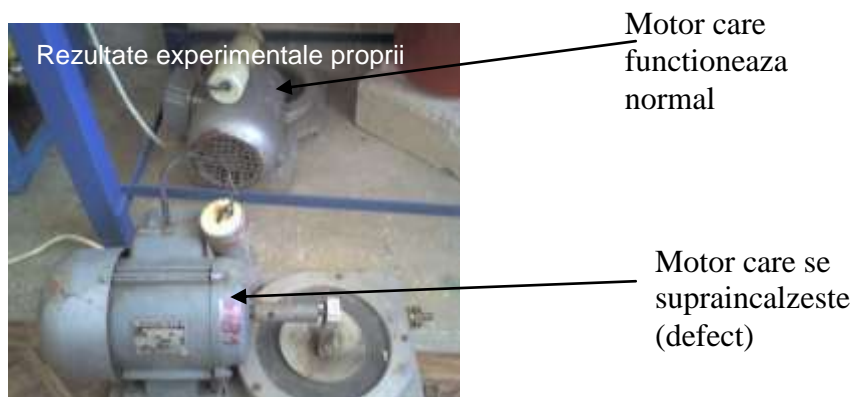
Figura 12.
Figure 12.

One of them is in load, and the other one has the load decoupled and I monitored for 15 minutes the start (evolution of its temperature over this period) and then I stopped the supply.

In figure 12 the two engines can be seen.

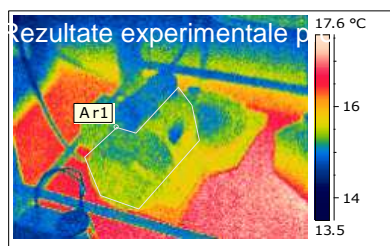
In figura 13 si figura 14 sunt termogramele celor doua motoare inainte de a le porni, la temperatura mediului ambiant de $16^{\circ}C$:

In figures 13 and 14 are the thermograms of the two engines before running, at environmental temperature of $16^{\circ}C$:

Figura 13 Motor inainte de a fi alimentat

Figure 13 Electric engine before running

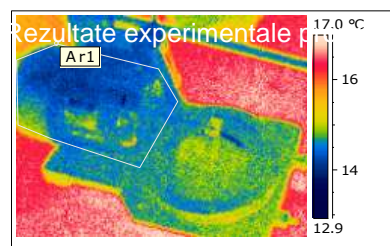
Figura 14 Motor defect inainte de a fi Alimentat

Figure 14 Faulty electric engine before running

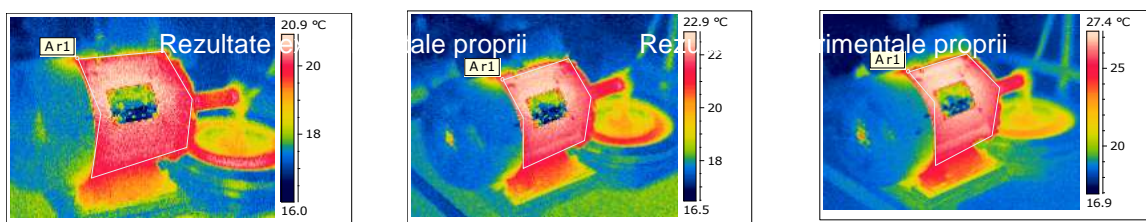
In continuare vor fi prezentate cateva termograme (figurile 15 si 16) ce reprezinta incalzirea, puse in paralel pentru cele doua motoare pentru a evidentia viteza de crestere a temperaturii pentru cel defect (figura 16) comparativ cu cel care functioneaza normal (figura 15), cel defect atinand un maxim de aproape $60^{\circ}C$ in 15 minute, pe cand celalalt

Further on will be some thermograms in parallel (figures 15 and 16) which represent the heating of the two engines in order to point out the speed of temperature rise for the faulty engine (figure 16), compared to the one that functions normally (Figure 15), the faulty one reaching a maximum of almost $60^{\circ}C$ in 15 minutes, when the other

Figura 15. Termograme reprezentând încălzirea motorului ce funcționează normal
Figure 15. Thermograms representing heating of the normal functioning engine

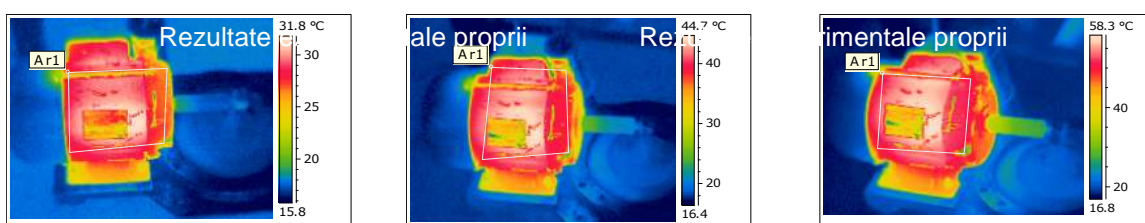
de doar 27,4°C în același timp. Și pentru acest caz s-a trasat curba de pornire în figura 18.

of only 27,4°C in the same time. For this case also a starting curve was drawn in figure 18.

Figura 16. Termograme reprezentând încălzirea motorului defect
Figure 16. Thermograms representing heating of the faulty electric engine

Case 3

Two identical engines, being in the same conditions, are started in the same. In 15 minutes of observation, one will be with 30°C hotter than the other because its decoupled load.

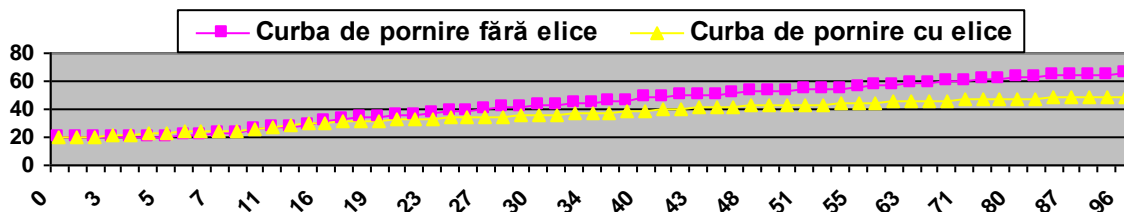
Figura 17.
Figure 17.

Case 1

Electric engine goes in 96 minutes from environmental temperature of 19,5°C to 49°C, which proves a functioning in normal limits.

Case 2

When we run the same electrical engine in Case 1 with initial temperature of 19,5°C, in 96 minutes (almost an hour and a half) it will reach 65,5°C. This exceeds a lot its nominal functioning temperature which is between 40 and 50°C. This happens because of lack of ventilation.

Pentru cazurile 1 si 2 avem curbele de pornire trasate in figura 17, iar pentru cazul 3, curbele de incalzire sunt trasate in figura 18.

curves in figure 17, and for case 3, the starting curves are drawn in figure 18.

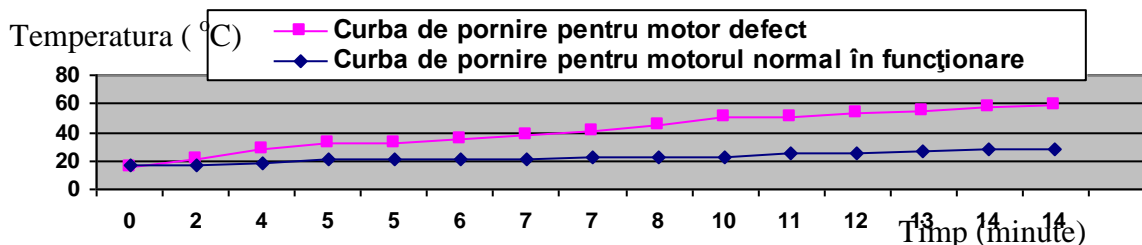
Figura 18.
Figure 18.

From the 4 curves in figures 17 and 18 that are resulted from the 3 cases, I deduce:

- two situations in which engines seem to work in normal conditions (in 96 minutes engine in Case 1 reaches from 19,5°C to 49°C, and in 15 minutes engine not faulty in Case 3 reaches from 16,7°C to 27,4°C) and
- two situations in which normal functioning temperature of an electric engine is exceeded (in Case 2 engine with no ventilation reaches from 19,5°C to 65,5°C in 96 minutes and in Case 3 engine with uncoupled load reaches from 15,9°C to

58,3⁰C in 15 minutes).

In the last two situations, seeing only the graphics I cannot know the cause that leads to temperature increase. I can only conclude that temperature increases over normal limits. This leads to the hypothesis that the diagnosis of an electric engine in abnormal state of functioning (faulty) cannot show the fault, so the purpose of the experiment, meaning that to determine weather behaviors during functioning of various electrical engines with a thermovision camera offers enough diagnosis data which could further be used to diagnose any other type of electric engine during functioning was reached, namely that the data offered by diagnosing an electric engine are not enough to generalize, and they could not lead to determining the cause of failure, because two different causes may lead to the same graphic through thermographic. We know it's out of order, but we don't know why.
