ASPECTS REGARDING EXPERTISE THE MECHANISM OF RIDING OF ELINDE FROM THE COAL EXTRACTION MACHINE

ABSTRACT: In this paper presents the technical state in which it is found in which is the mechanism of lifting ladder from the coal extraction machine, following technical expertise. Rehabilitation to which the lifting mechanism will be subjected of the ladder will be done through the execution of the intervention works which will return to normal operating parameters both the structural part and the functional part. In the work paper are presented: verification procedures of the mechanism as well as the technical solutions proposed to repair the mechanism.

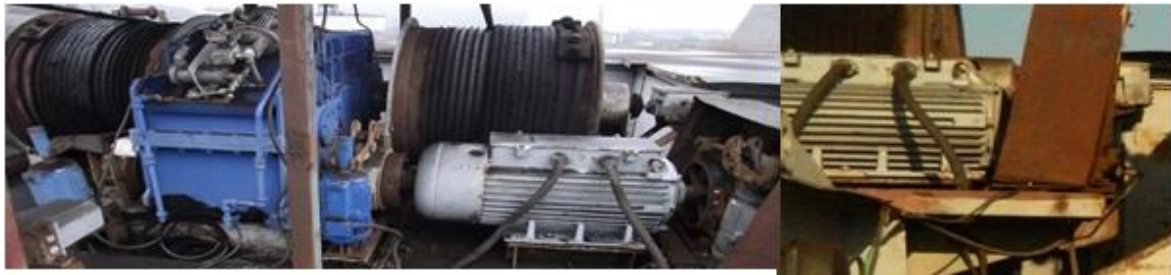
Fig.1. The mechanism of lifting ladder

The mechanism is driven by an electric motor, with two shaft ends, on which is mounted the drive coupler and respectively coupling with additional brake washer and tachogenerator. Movement is transmitted to a cylindrical reducer with two-head input shaft on

which two brake couplings are mounted, one constituting the corresponding coupling with the one on the engine, and the one the second is used as a safety coupling. On these brake couplings are mounted articulated brakes with sabots and electro-hydraulic lifts.

Lifting cable, mounted on drums is positioned over the cable wheels what is forming the system of rolling, but also over the roll in the mobile box with the role of mobile weight of balancing provided with warning and stop limiters of the descent. This is part of the lifting mechanism of the ladder being of galvanized type, with a thick layer of zinc applied thermally, with a metallic heart.

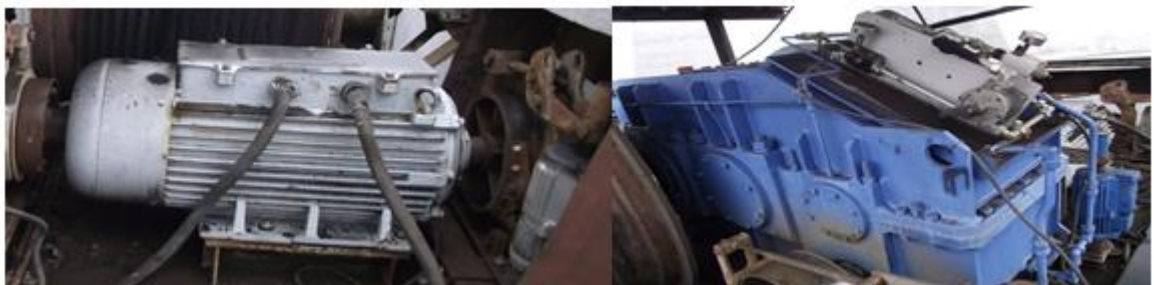
Fig.2. The reducer and the drive motor

The reducer (fig.2) has the lubrication system under pressure, but it also has losses at the entrances or exits of the plant from its housing, as well as on the installation, in the adjustment zone.

- will be eliminated oil losses of the transformer of electrohydraulic lifters (REH).

It is necessary to control bolts and rubber bushings of the coupling between the motor and the gearbox.

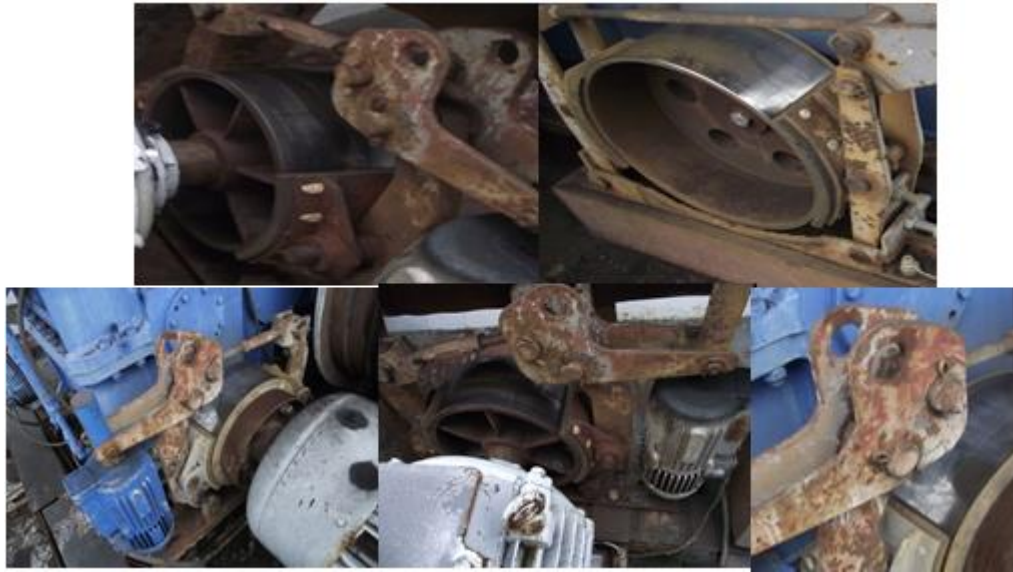
Fig. 3. The brakes of the mechanism

Wears are visible in bolt-bore couplings on the brakes mechanism of lifting.

Linings on the brake sabots are worn out.

The three brakes have electrohydraulic lifters with shock absorbers, but they have oil losses, with the exception of the service brake (unregulated). Also, large wear was

found on the safety brake, although this brake must work when closing, after complete shut down of the mechanism and will get up 2-3 seconds before of power supply of the electric motor.

they will be restored couplings so their games be consistent with the ones presented in the machine documentation and will be remedied by replacing the linings from the brake sabots them. Also, will do:

- brake adjustment (electrohydraulic lifters REH) electrohydraulic lifters on the lifting side and the side of the descent as execution times.

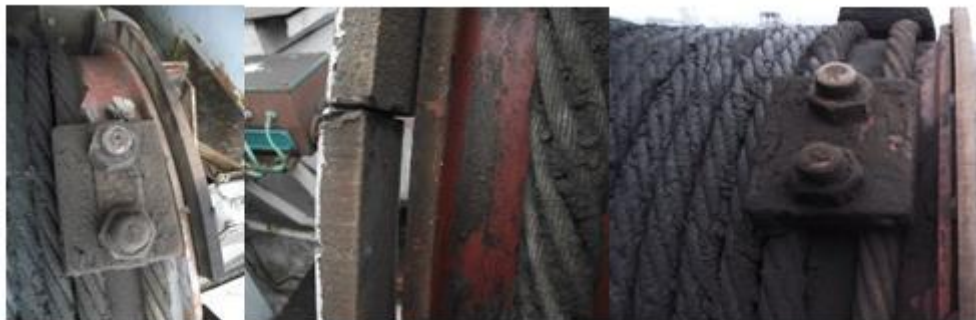
Fig.3. The drum of the lifting cable

In the case of the cable from the lifting mechanism, it has been noticed that the nuts have not been secured by bending the sheet fuses, on their sides, to three from fastening brackets of the

cable, and at the fourth one is missing the fuse. The importance of these fuses bended is that the nuts they can not loosen that to allow detach the cable.

Mounting the segments on the end flanges of cable drums was inappropriately made, being a great execution mistake, they can detach away due to vibrations out of operating time and can cling cable which can be damaged up to breakage and from here may result in a serious technical accident. It should be noted that, when installing the cable on the drum, the ends of the cable must have a length that measures at least $10 \times \Phi_{\text{cable}}$, at the exit from the clamp, so it is ensured against unplait, for safety against pull-out the cable in the clamp.

- checking the clamps at the ends of the lifting cable on the drums of mechanical cable;

- insurance with fuses of sheet metal of nuts from the cable clamps and completing the fourth which is missing;

- welding the ends of the segments who are attached on the discs of the drums cable, without being finalized and welding between the segments and the discs of the drums (Finalization will be made when the atmospheric temperature is over 15°C, for three consecutive days and the temperature will be at night of over 10°C),
