## **ASPECTS REGARDING THE EXPERTISE OF LIFTING-DESCENT MECHANISM PLATFORM OF A COAL EXTRACTION MACHINE – Part I**

**ABSTRACT:** in this paper presents the technical state of the platform of uplift-descent the mechanism of the coal extraction machine, n following technical expertise. The rehabilitation to which will be subjected of the platform of uplift-descent the mechanism will be done by performing the intervention works which will restore in the normal operating parameters both the structural part and functional part. Also, in the paper are presented: the verification methods of the mechanism as well as the proposed technical solutions for the repair of the mechanism.

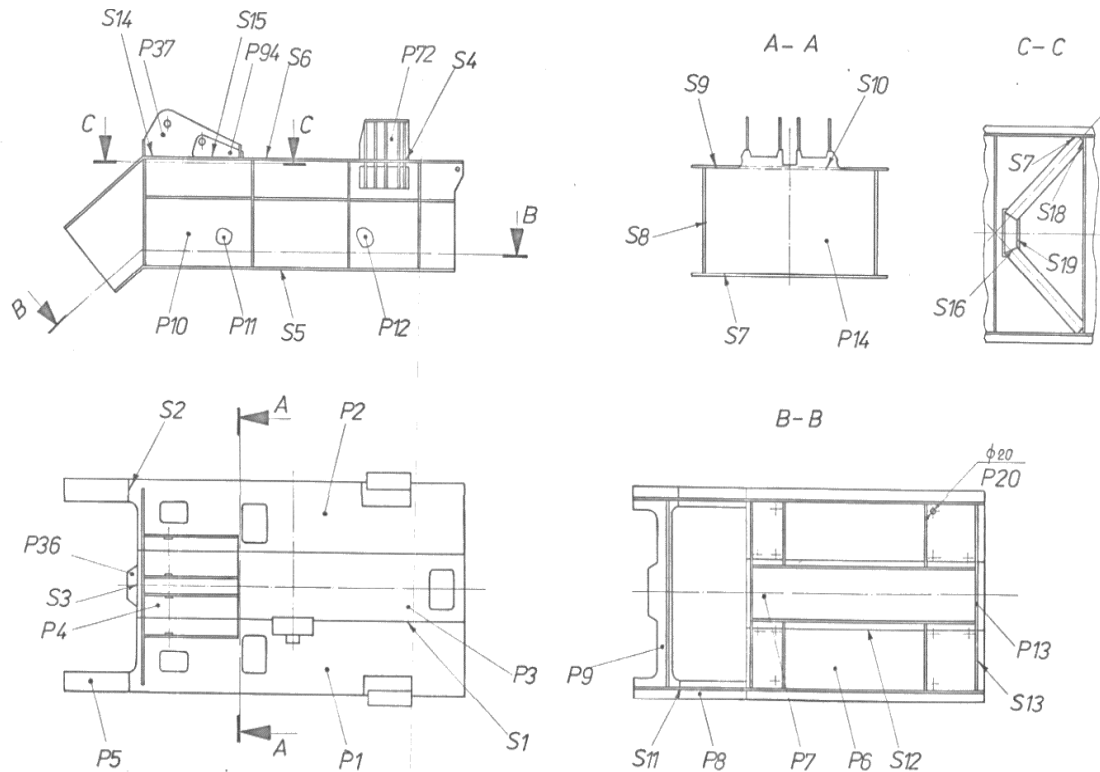
**Fig.1. The upper platform of the lifting mechanism**

Inside this platform, as can be seen in Fig.1, section A-A, will slide „mobile box”, and in the compartments P6 and P7 are the places sitting of the fixed balancing lest of the rotating superstructure of the machine. On the lower rear side, position P8, is

mounted the transverse girders what support electric booths of the apparatus. The positions P37 are made of two welded parts at mounting, on site and, due to their importance, will be controlled in the stretch-traction area of the cord welding.

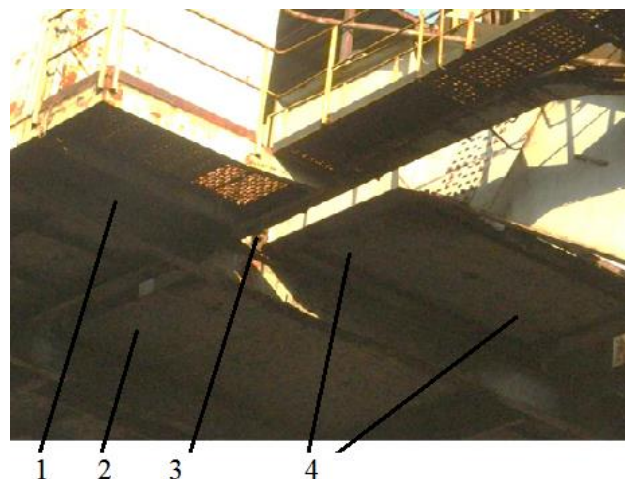
**Fig.2. The platform of mechanism**

In fig. 2 is showed the platform of the lifting mechanism - bottom view- in which it is distinguished: the platform (1), gripping mode of the support beams (3) gripping mode of electrical cabins (2) and the mobile box of lest (4).

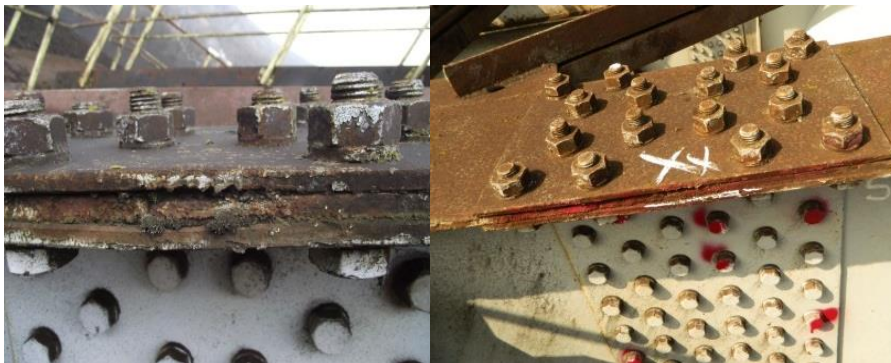
Following checks made found more defects o different parts of the mechanism, of these defects can be enumerated: rusting the assembly elements (screw nut) both at the center and at the edge of the ladder (catching the countearm) fig.3; rusting assembled sheets; rusting the area in the main heart, on the side from the platform; the occurrence of material cuts at the grip of countearm on superior girder against wind to the front plat, fig.4, surface defects etc.

**Fig.3 Rusting the assembly elements and rusting assembled sheets.**

- rusting the assembly elements (screw nut both at the center and at the edge of the ladder;
- rusting the area in the main heart, on the side from the platform;
- controlled welds did not presented defects which could jeopardize the machine;
- the welded structure of the assembly has no major deficiencies from the basic documentation except that oxy-gas cuts have been performed without complying with the technical specifications, which is why they must be repaired.

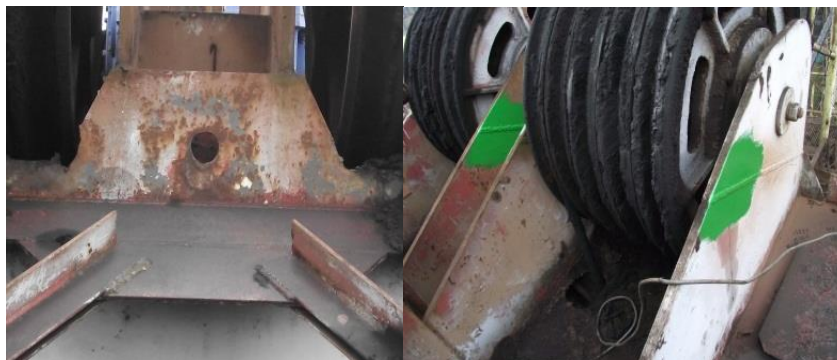
**Fig.4. Surface defects**
