ASPECTS REGARDING THE TECHNICAL EXPERTISE OF ELECTRIC EQUIPMENT CABIN OF THE COAL MINING MACHINE

Abstract: *In this paper we presents technical condition, how it looks and which deffects are electrical cabin of coal mining machine after technical expertise made it. The rehabilitation to which electric cabinets will be subjected will be done by performing the intervention works that will restore both the structural part and the functional part in the normal operating parameters. The paper presents the failures found in electrical cabinets as well as proposed solutions for their repair.*

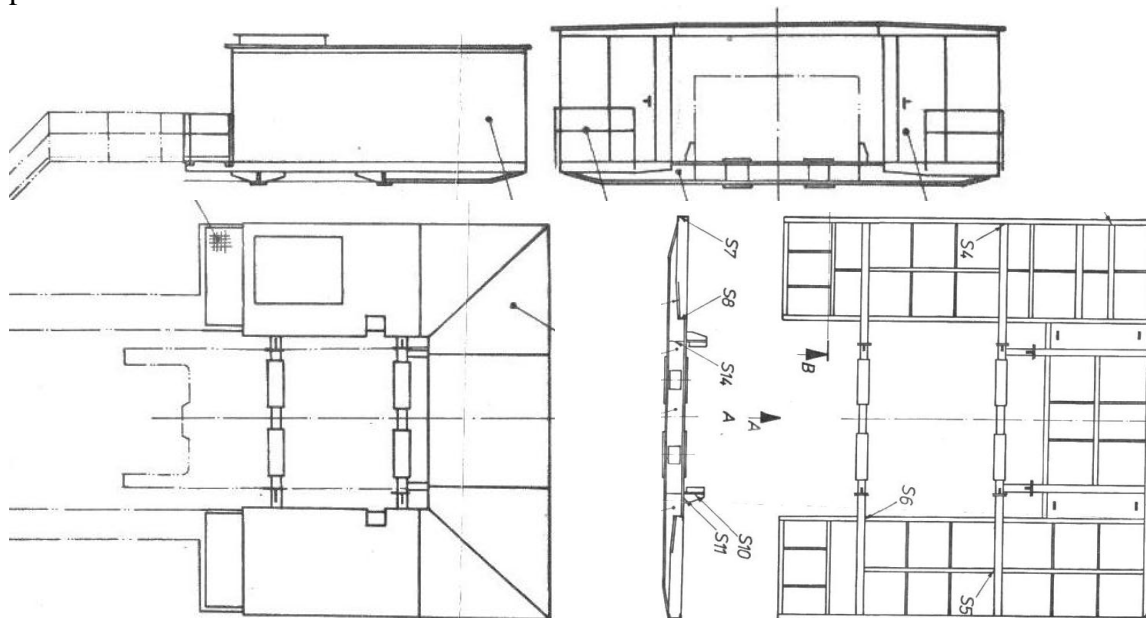
Fig.1. Drawing electrical cabins and supporting beams

There are electrical cabinets located on the side of the lift mechanism platform, around it on three sides with access on the balancing arm and placed on transverse beams. Seating beams constitute and support the floor of the cabins and they pass under the top platform.

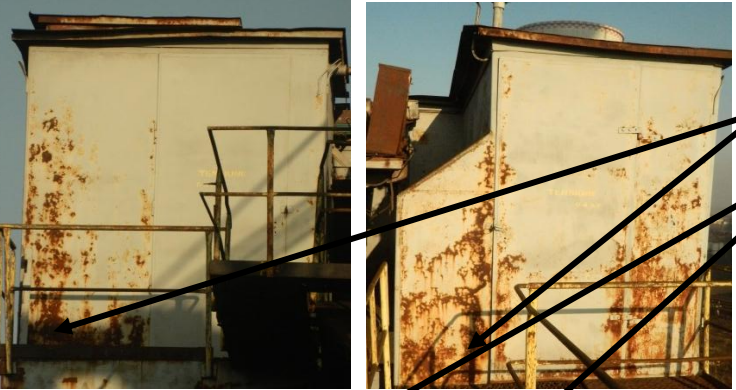
<p>The side walls and the access doors in the electrical cabins have degraded paint surfaces and rusting through the cover sheet.</p> <p>Degradation is particularly noticeable when joining the wall with the floor, where it has accumulated and charcoal dust.</p> <p>It is necessary to replace degraded portions, clean and protect corrosion.</p>

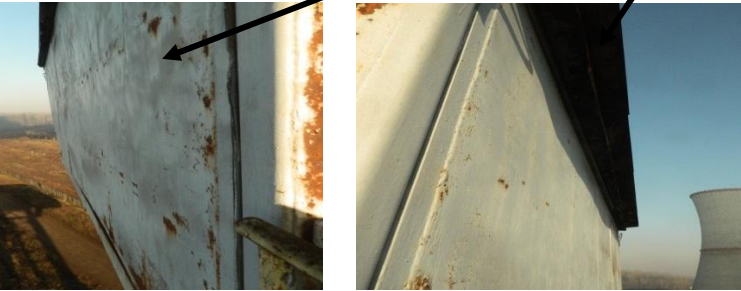
<p>Degradation is visible on both sides of the cabin.</p> <p>The corrosion phenomenon also occurs when joining the walls with the roof, visible and on top of the roof.</p>

<p>It is imperative that an anti-corrosive coating is applied during the repair.</p>

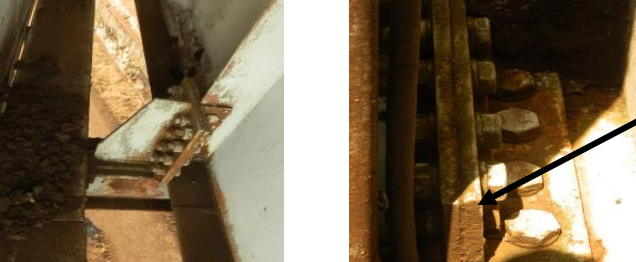
<p style="text-align: right;"><i>Face</i></p>	<p>The fastening of the electric booths on both the front and rear side of the beam, as well as the precipitation water with deposits of coal dust, came to the right.</p> <p>It is recommended to repair the fastening or, as the case may be,</p>

<p>to clean and protect the corrosion protection.</p>
		<p>The ceiling of rusty and deformed booths as a result of supporting by placing various pieces on it. Cut-off but leaky cuts on the ceiling that allowed water to penetrate. The non-sealed welding between the structure of the electrical house and the roof allowed the penetration of water. The appearance of water through the perforation of the roof will be repaired.</p>
		<p>Extended roof areas with rust that can perforate. Same phenomena on the floor and / or the joining between the floor and the walls. The cabin structure is not affected. The high voltage side will be checked during repair (access was not possible-HSW)</p>
