NON-DESTRUCTIVE CONTROL ON QUARRY MACHINERY TYPE ERc 1400-30/7

ABSTRACT: Non-destructive analysis, visual control and penetrating fluids methods as well as ultrasonic thickness control are easily applicable to machinery in lignite quarries and can reveal major defects on both the load-bearing structure and the main kinematic elements of the safety mechanisms.

3. Case study – Non-destructive analysis for ERc 1400-30/7

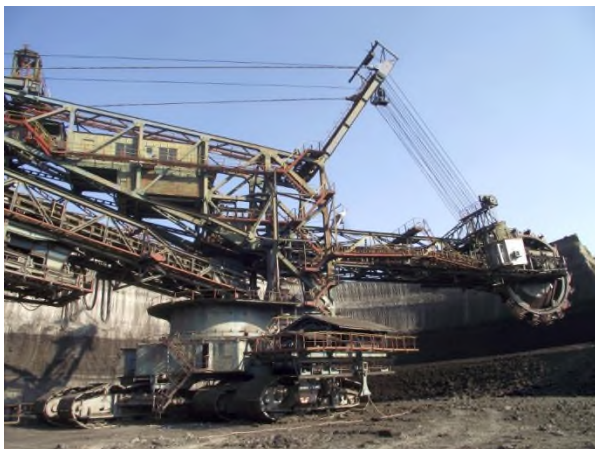
The main equipment for the stripping of sterile material or the excavation of lignite is the excavator with rotor type ERc 1400-30/7, Figure 1, originating from the German variant SRs 1400 designed by KRUPP, assimilated in Romania [2, 6].

Figure 1 - The excavator with rotor type ERc 1400-30/7

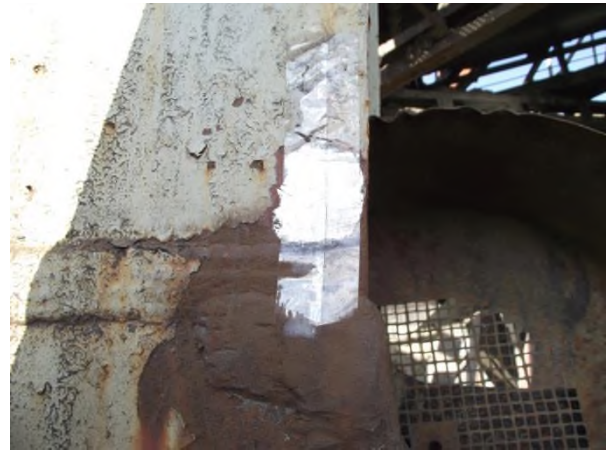
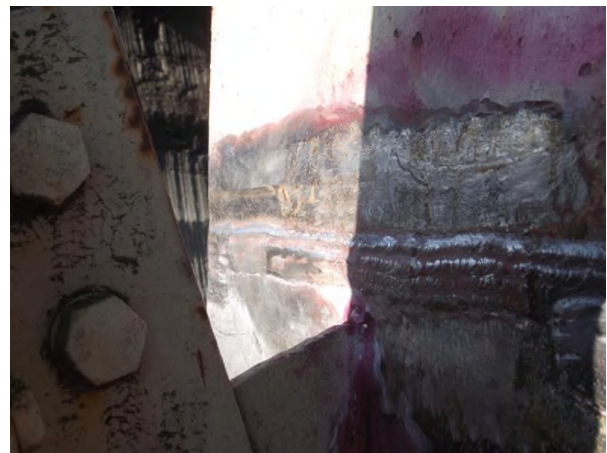
Although it does not have excessive load, the node pillar 8', figure 2, after visual control did not show microcracks, figure 3.

Figure 3 - Lack of microcracks in visual verification

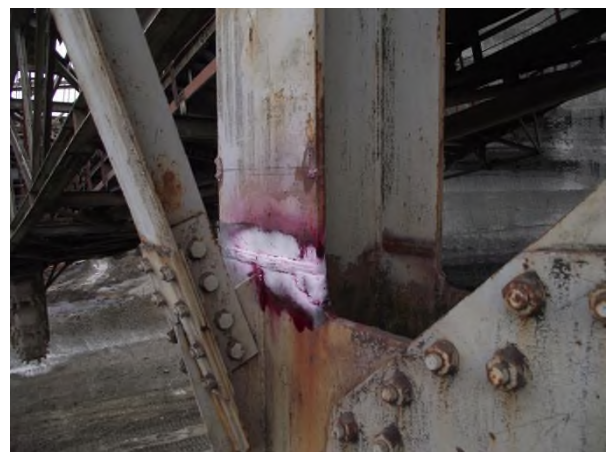
On a closer inspection with penetrating liquids, the microcracks were highlighted, figure 4, figure 5.

Figure 4 - Application of the developer to the micro-cracked area

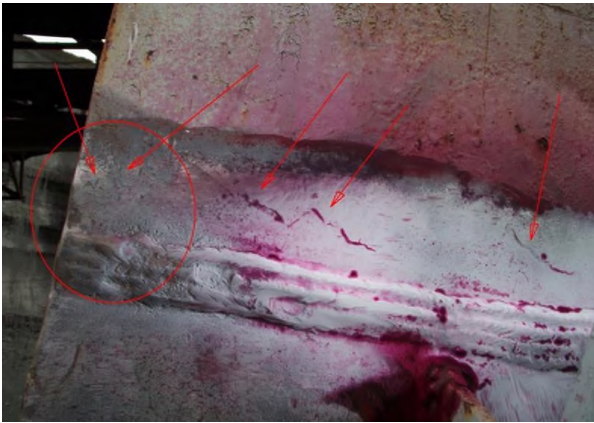
Figure 5 - Microcracks in the area of ZIT and fatigue

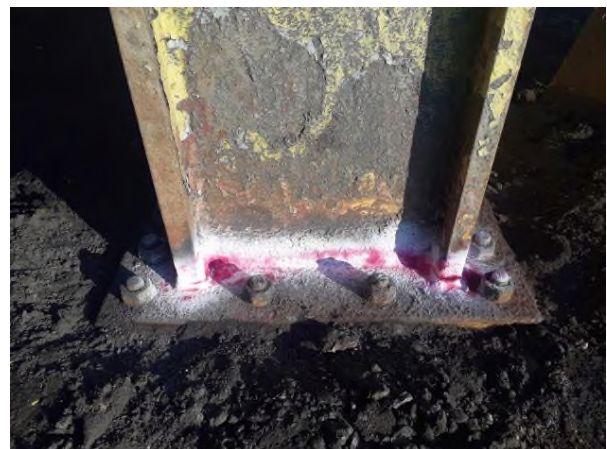
Another situation in which both the visual control and the one with penetrating liquids is used is the verification of the screws and of the possible cracks at the base plates of the pillars of the tower node 8` and 8.

Thus, after cleaning the area, applying the penetrating liquid, removing the excess liquid and applying the developer, the area was checked, figure 8.

Figure 8- Examination of the welded joint of the base plate - column node 8` and 8

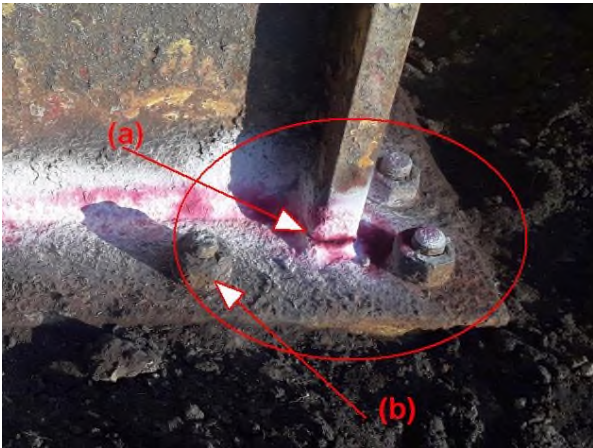
If the visual cracks could not be observed during the visual inspection, figure 9 by applying the method with penetrating liquids was found both the crack area, figure 10.a and the damage of the fastening screws, figure 10.b.

Figure 10 a. Crack on the base plate-pillar;
b. Damaged screws

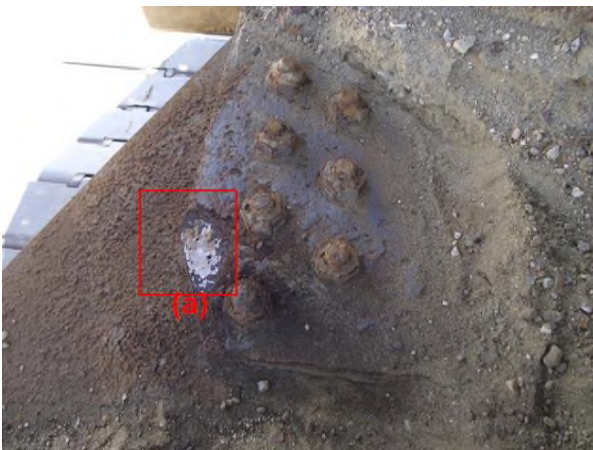
It is often applied the combination of the visual inspection method and the thickness measurement method is, Figure 11

Figure 11 a. Cleaning the area for ultrasonic control
