EXTENDED TECHNICAL INSPECTION OF THE LIFTING MECHANISM SUPPORT PLATFORM OF THE M5A COAL REMOVER

1. INTRODUCTION. LIFTING MECHANISM SUPPORT PLATFORM

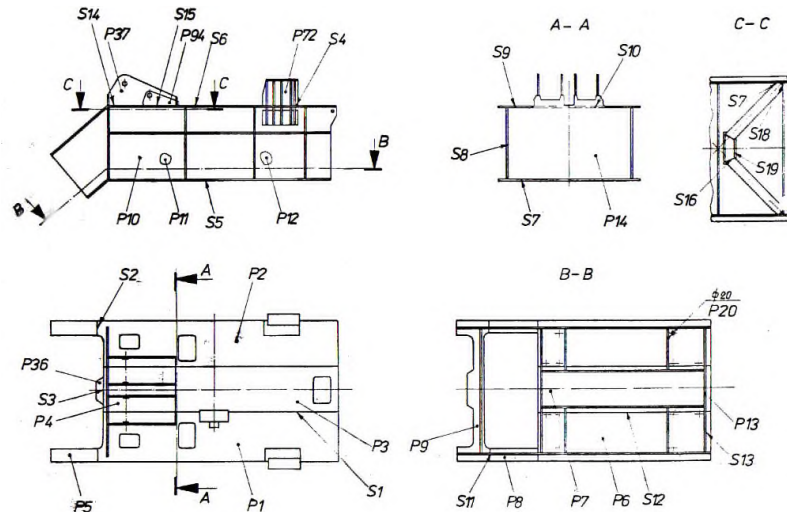
Fig.1 - Support platform of the lifting mechanism

Figure 1 shows the identification sketches of the support platform of the lifting mechanism.

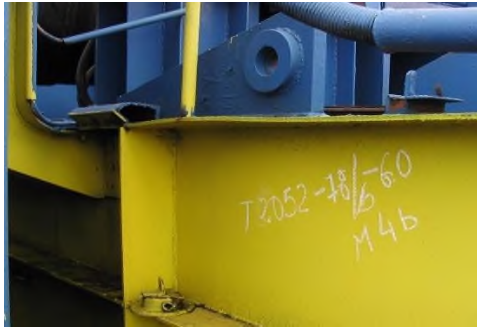
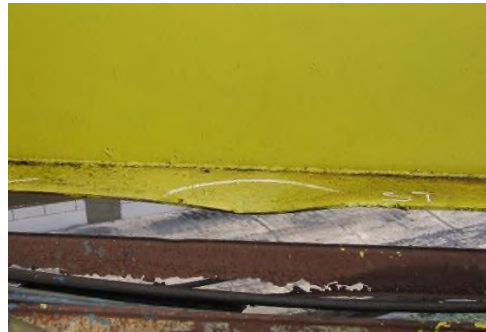
Fig.2.

The upper sole pos. They must be straightened during the repair fig.2.and fig.3. They will straighten out during the repair with the unloading of efforts.

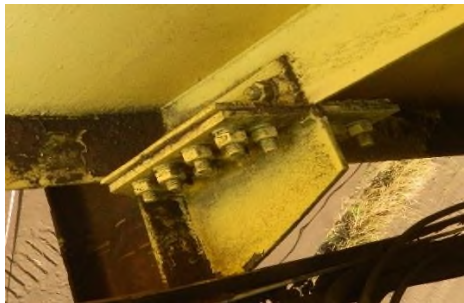
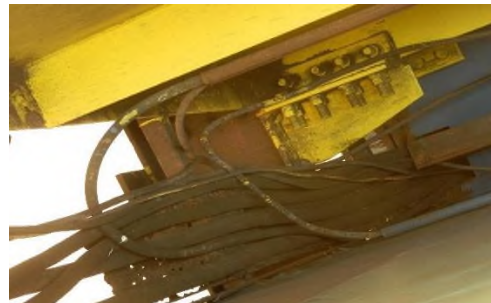
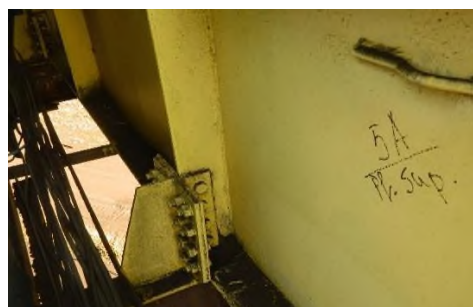
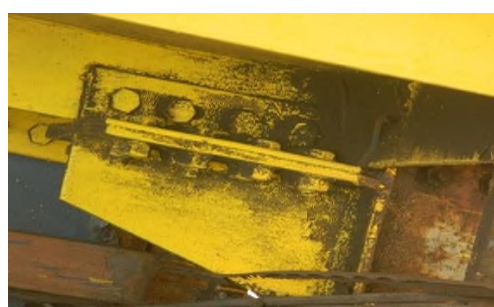
Fig.4

The connection of the ballast box that constitutes the support of the lifting mechanism by the beams on which the

upper electrical cabins are placed is without visible problems. During the repair, the joints shown in fig. 4-7.

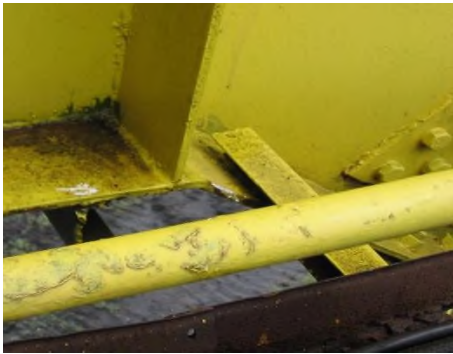
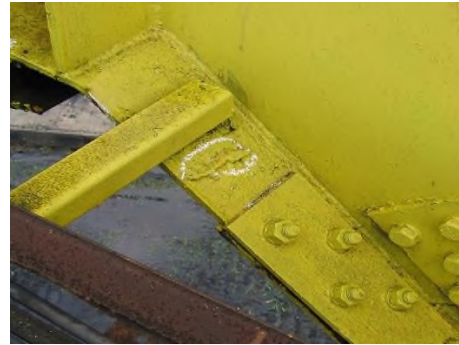
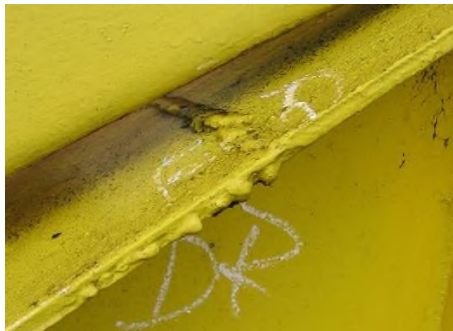
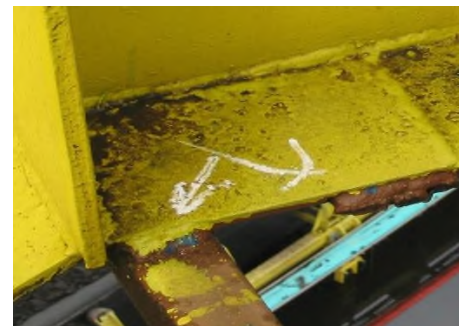
Fig.8

Unauthorized welding was performed on the metal construction of the box. It must be removed, polished and executed during

the repair period, control with penetrating liquids, fig. 8-11.

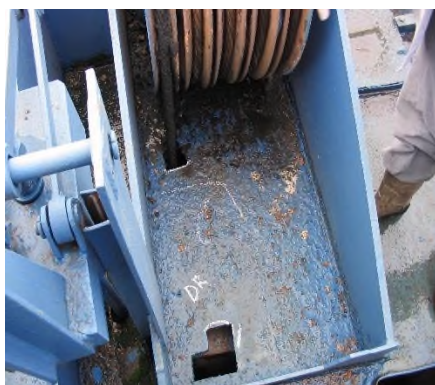
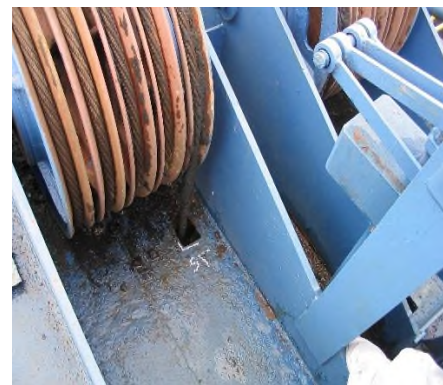
Fig.12

Holes with irregular contours were drilled in the upper plate for the passage of the lifting cables. They must be adjusted to a

round shape, welded reinforcements, checked, fig. 12-13.

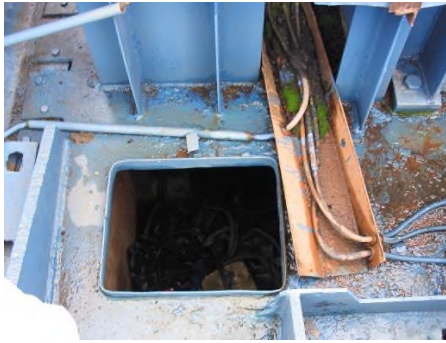
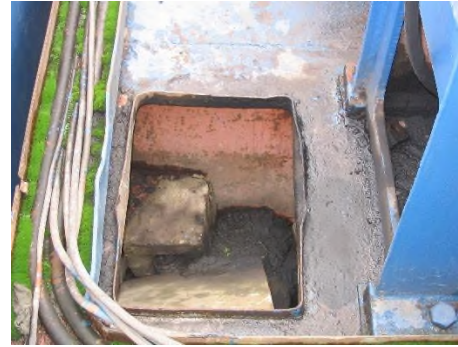
Fig.14

No lids were mounted on the ballast box and therefore water accumulated and was transformed into a garbage can, fig. 14-15.

The box must be emptied. Carefully mount the machine.

Protected water drainage holes will be drilled.

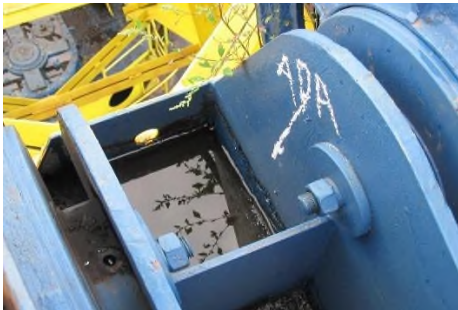
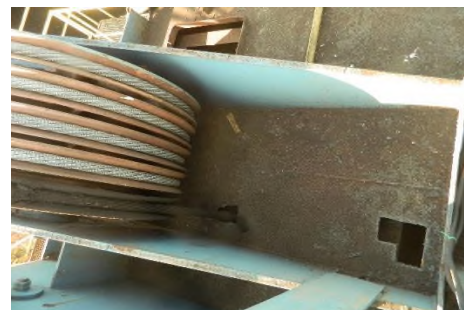
Fig.16

In the roller battery holders there are various deposits, fig. 16-17. Cleaning and corrosion protection are required.
