STRUCTURAL INTERVENTIONS FOR THE REVITALIZATION OF A WATER MILL

ABSTRACT: This paper presents a case study on the Riesz Mill in Valeapai, Caraş-Severin, Banat Region, focusing on the structural rehabilitation strategies that ensure both the preservation of its architectural and historical integrity, but also its reintegration into the rural economy through tourism and sustainable development. Structural engineering solutions are proposed for its rehabilitation, focusing on reversible and compatible interventions on stone, brick, and timber elements. The approach integrates traditional materials with modern reinforcement techniques to ensure both structural stability and authenticity. The restoration aims to preserve the original mechanical equipment and architectural identity while adapting the ensemble for public use through tourism and education. By combining engineering innovation with heritage conservation, this paper illustrates how sustainable structural interventions can stimulate rural development and revitalize local communities.

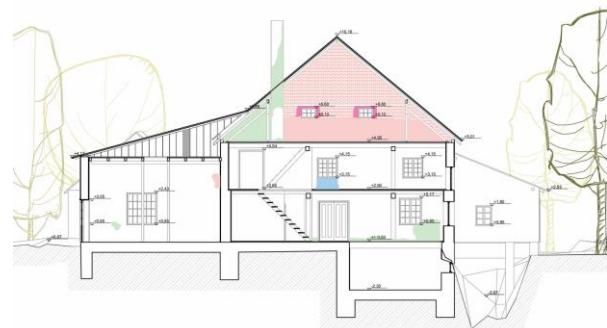
Fig. 1 – Structural system

The mill's primary load-bearing walls are built of solid brick masonry, while the annex additionally integrates structural steel elements, fabricated from repurposed railway rails. The ground slab and intermediate floor decks are composed of timber planks supported on wooden beams, whereas the floor slabs of the annexes and basement are constructed from reinforced concrete. The roof structure is a timber truss system. (Fig. 1)

The interaction between these materials creates specific vulnerabilities: differential settlements, humidity-related degradation, and loss of rigidity at timber–masonry joints.

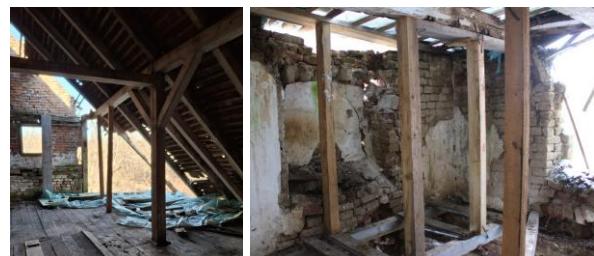
Fig. 2 – Collapsed zone

The northern section of the building is the most severely affected, where the intrusion of invasive vegetation has led to partial collapse of the masonry walls. (Fig. 2)

Reconstruction of this area should be carried out using traditional building techniques, carefully replicating historical materials and workmanship, while simultaneously ensuring that the rebuilt structure meets current structural performance requirements based on engineering calculations.

Interventions must respect the historical material compatibility and avoid rigid modern mortars that could damage the masonry.

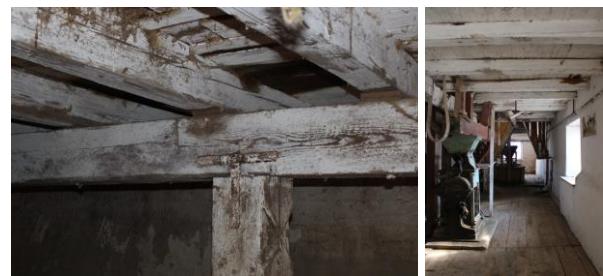
Fig. 3. – Timber structure

At the ground floor and basement levels, the structural system comprises transverse timber beams measuring 120×120 mm and longitudinal beams of 240×200 mm. On the upper floor, the transverse beams are 210×180 mm, while the longitudinal beams remain 240×200 mm. (Fig. 3)

The span at this level is greater than at the lower floors, which results in increased bending moments and higher structural demands on the upper beams. For a proper assessment, the bending stress of the upper floor beams should be evaluated using the standard formula.

If the calculated bending stress approaches or exceeds the allowable stress for the timber species, reinforcement measures such as steel plates or additional support must be considered to ensure structural safety and durability.
