DIAGNOSTICS OF ELECTRICAL INSTALLATIONS BY THERMOGRAPHY

Adriana Comarlă, “Constantin Brâncuși” University from Târgu Jiu, ROMANIA
Francise Comarlă, “Constantin Brâncuși” University from Târgu Jiu, ROMANIA

6.CASE STUDY – THERMOGRAPHY OF ELECTRICAL INSTALLATIONS ON AN ELECTRICAL PANEL EQUIPPED WITH MPR FUSES

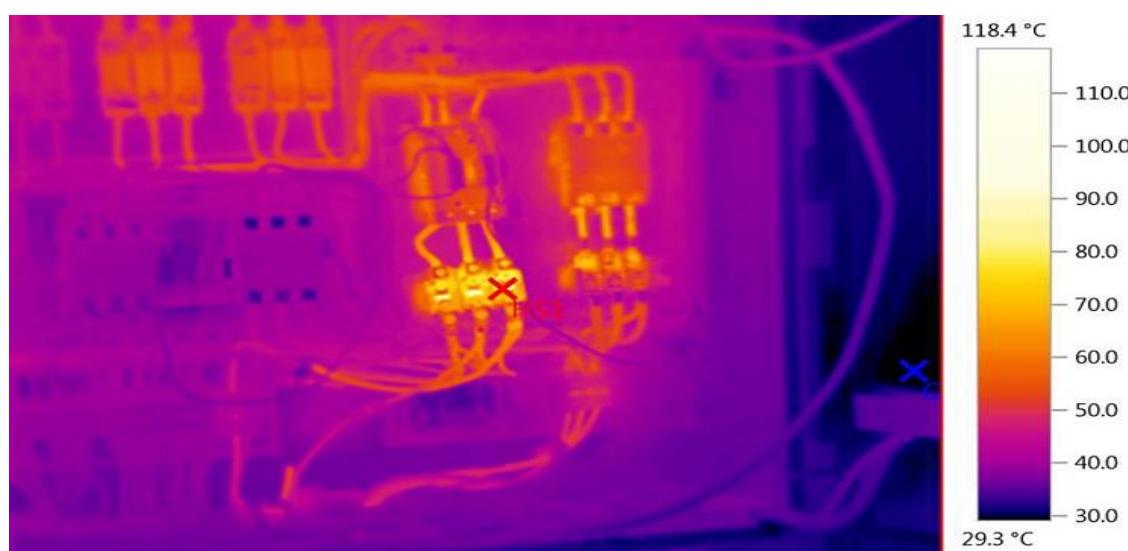
Figure 2 Imperfect contact

1. **Imperfect contact.** Unlike overload operation, where the temperature of the circuit is constant along its entire length, when we have

an imperfect contact, a hotter point will appear on the infrared image which is the source of the defect, and as we move away from it, the temperature will decrease. Causes: loose connections (electrical slippers, loose screws, deformed string clamps, unused flexible conductor pins)

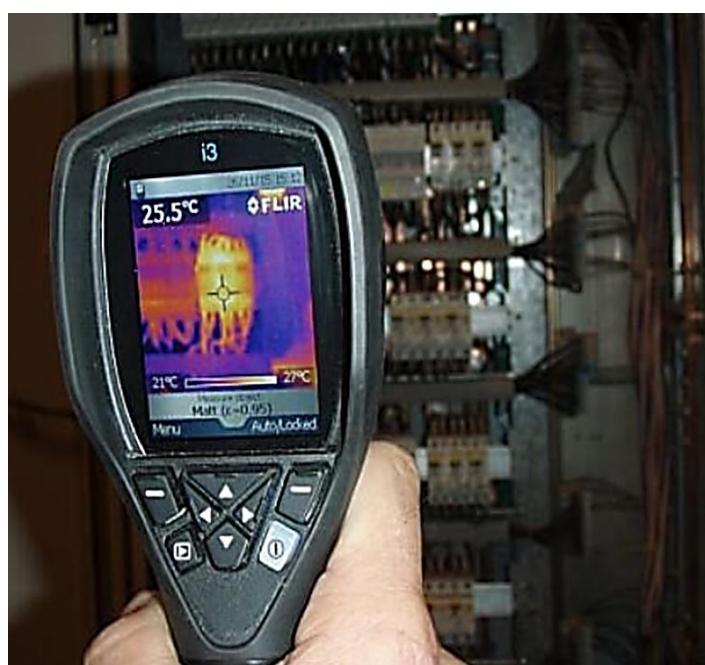
Figure 5 Thermal imaging camera

A thermal imaging camera works by detecting and measuring the

infrared radiation emitted by objects, then converting this

radiation into visible images, called thermograms, that show the temperature distribution. In other words, it captures heat, not visible light.

- For electrical panels: it is measured from $0.5 \div 2$ m, depending on the resolution of the room.
- For medium/high voltage power lines: cameras with special lenses are used, from
- $10 \div 30$ m.
- A tripod that focuses correctly is used for reliable results.
- It calibrates the emissivity and corrects the background temperature according to the material being measured.
