CAVITATION EROSION RESEARCH ON C45 CARBON STEEL. PART II: EXTENDED DURATION FOR 900 MINUTES

ABSTRACT: This paper, based on the experimental results obtained in the research, presents the cavitation erosion resistance of the C45 carbon steel. These researches involve only one test of 900 minutes for 20 periods of 45 minutes, which mean a total time of 15 hours. Depending on these results, the material loss curve was obtained and also the cavitation erosion rate experimental and analytic curve was obtained.

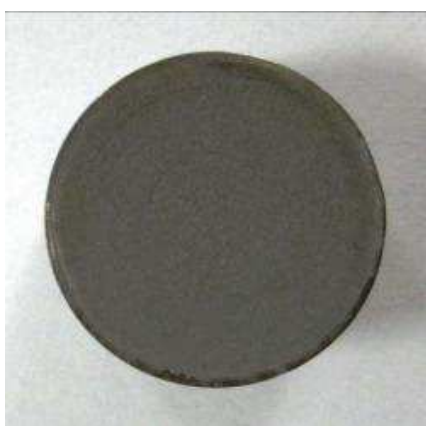
Figure 4 shows images of the eroded surface and also the macrostructure after a total of 900 minutes.

a) Image after 360 minutes

Figure 9: Macrophotos of the C45 steel surface after cavitation

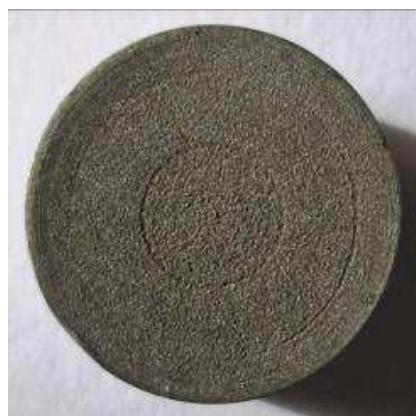
b) Image after 900 minutes

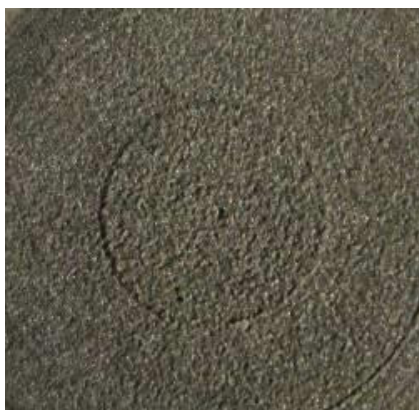
c) Macrostructure after 900 minutes
