RESEARCH ON THE CAVITATION EROSION RESISTANCE OF THE X3CRNI13-4 STAINLESS STEEL USED TO MANUFACTURE THE RUNNER BLADES OF KAPLAN TURBINES

ABSTRACT: This paper presents beside the theoretical concepts about the Kaplan hydraulic turbines, also the experimental results of cavitation erosion research regarding the resistance of the X3CrNi13-4 stainless steel that can be used to manufacture the runner blades of Kaplan hydraulic turbines. So, the cavitation erosion researches involve four different tests of 180 minutes on 2 samples of the same batch of X3CrNi13-4 stainless steel, so 3 hour for each test or a total time of 12 hours. These results are in tabular form, through charts and pictures, presented in this paper.

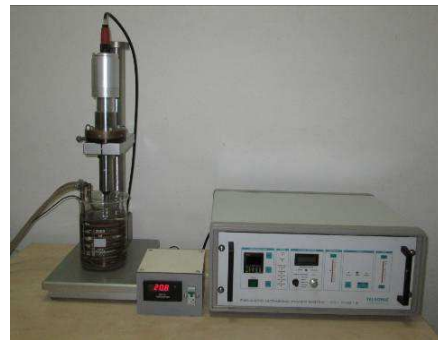
Figure 4. The cavitation stand

The cavitation stand (Figure 4 [24]), operates under the following conditions: natural frequency: 20000 ± 500 Hz; amplitude value: $50 \mu\text{m}$; temperature of the liquid: 25 ± 2 °C and the distance between the ultrasonic horn and the sample is 0.6 mm.

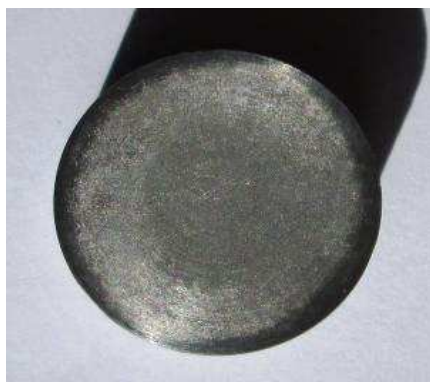
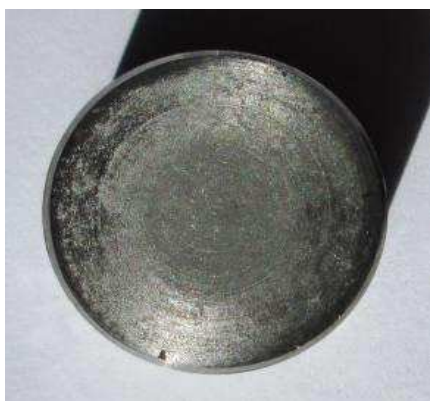
Figure 10. Macrostructures of the samples after the cavitation

Sample 1 - Face 2

Sample 2 - Face 1

Sample 2 - Face 2

The images after the cavitation had shown a clear view of the erosion, but for this batch of the X3CrNi13-4 stainless steel it can be concluded that assume a good cavitation erosion resistance.
