REGARDING THE QUALITY OF THE VEHICLE BACKSEAT FRAME ARMATURE RS 60%

Abstract: This paperwork identifies the unconformity from the backseat frame armature RS60% welding of a vehicle, respective the seatbelt bracket position. Causes and fixing that the seatbelt bracket not to be able to rotate around its axis.

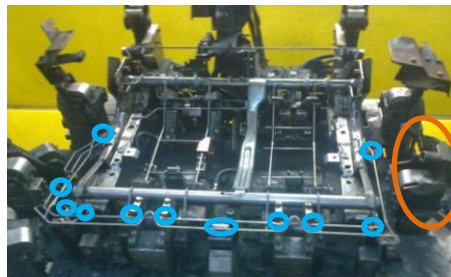
Fig.3 The welding device for the backseat armature 60%

After this study it was found out that the welding device was the main cause for the unconformity. Through a detailed analysis it was concluded that the welding device allowed the seatbelt bracket to rotate around its screw nut during its laying down on the welding device ,figure 11.

After the analysis, an improvement for the bracket fixing on the welding device was proposed, in this way the seatbelt bracket won't be able to rotate around its axis. This was replaced with a new fixing element which doesn't allow the seatbelt bracket to rotate,figure 12.
