## **ASPECTS REGARDING EXPERTISE OF THE ORIZONTALIZATION DEVICE OF COMMAND CABINE OF THE COAL MINING MACHINE**

**ABSTRACT:** This paper presents the technical state of the device for the alignment of a coal-mining machine after the technical expertise. The rehabilitation to which the control cabinet will be subjected will be carried out by performing the intervention works that will restore the normal operating parameters of both the structural part and the functional part. In the paper are presented: the means of verification of the device and the proposed technical solutions for the repair of the device.

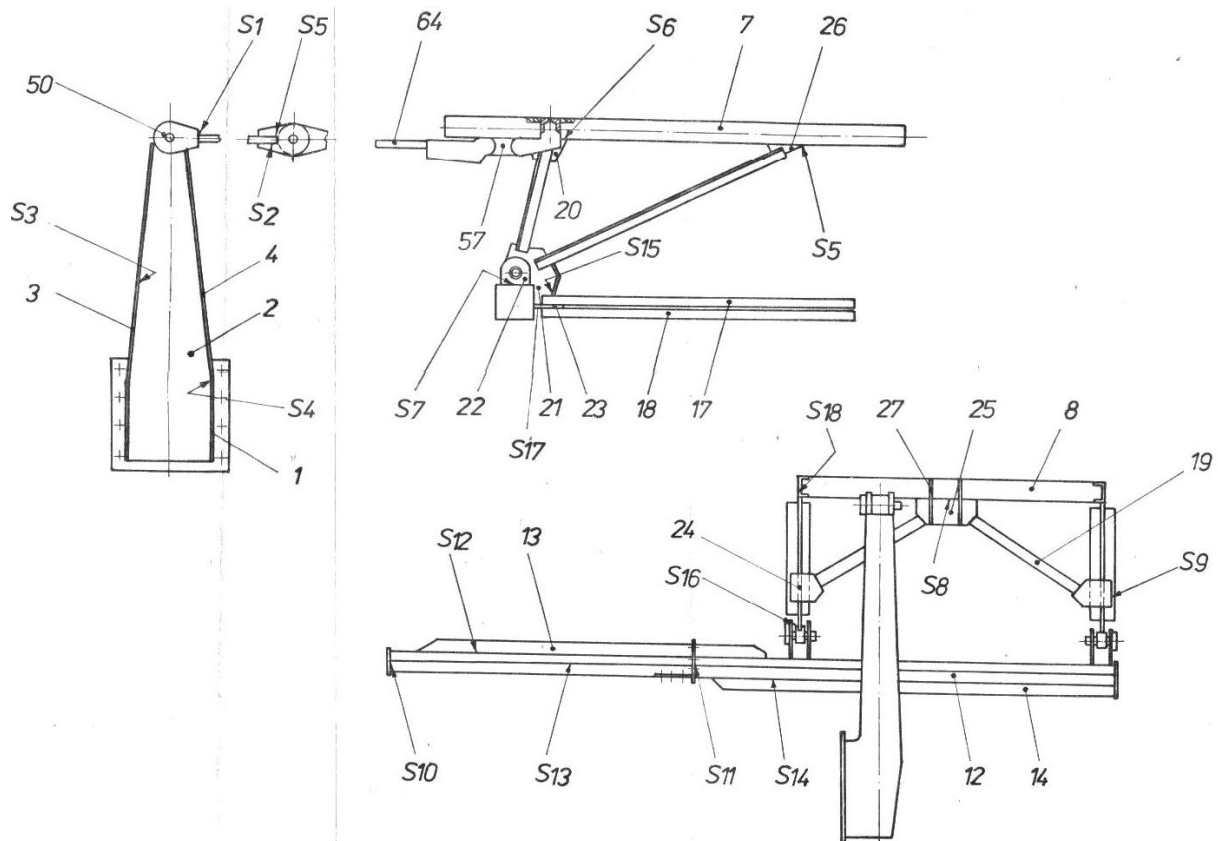
**Fig.1. Sketch of the device of horizontalisation of the control cabin.**

Figure 1 shows a sketch of the device of horizontalisation of the control cabin.
