TECHNICAL EXPERTISE OF THE WHEEL'S ARM - COAL EXTRACTION MACHINE - T2052

ABSTRACT: In this paper presents the technical condition of the wheel arm on which the cups are fixed from coal extraction machine T2052, following the technical expertise. The rehabilitation to which the metal beam lifting-lowering mechanism will be subjected will be done by executing the intervention works which will bring back to the normal operating parameters both the structural part and the functional part. The paper presents: the verification methods of the subassembly as well as the proposed technical solutions for its repair.

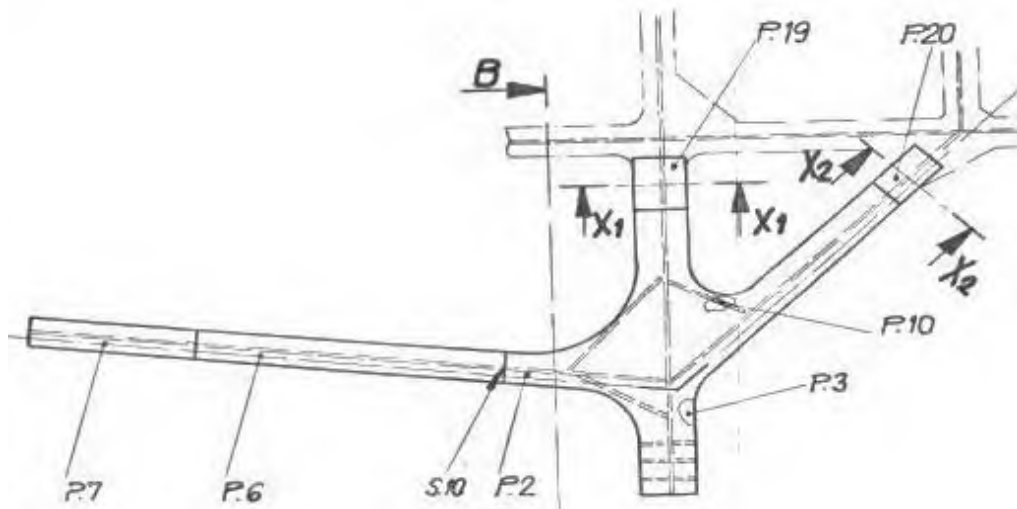
Figure 1. Sketch of section III (the port-cups wheel holder)

One of the first nonconformities encountered at the position 2 (see figure 1),

was the rupture of the soleplate and the heart of the support due to the twisted position of

The metal beam is twisted as a result of the overload, the rupture of section III appeared due to the axial force.
