## TECHNICAL EXPERTISE OF THE ROTARY PLATFORM - ASSEMBLY OF THE COAL EXTRACTION MACHINE - T2052

**ABSTRACT:** In this paper presents the technical condition of the rotating platform for coal extraction machine- T2052 , following the technical expertise. The rehabilitation to which the “rotating platform” assembly will be subjected will be done by executing the intervention works that will bring back to the normal operating parameters both the structural part and the functional part. The paper presents the verification methods of the assembly as well as the proposed technical solutions for its repair.

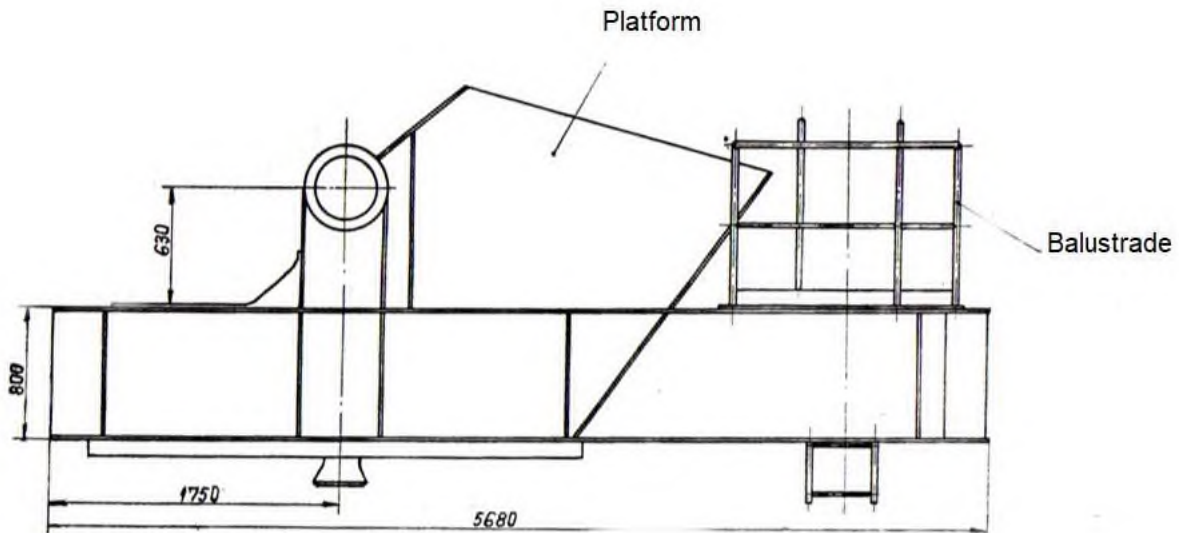
Figure 1. The structure of the rotating platform

The rotating platform is the subassembly that supports and is part of the superstructure, being of the welded caisson type, fig.1.
