THE EXPERTISE OF THE ENSEMBLE „THE METAL BEAM - SECTION II"- COAL EXTRACTION MACHINE - T2052

ABSTRACT: In this paper presents the technical condition in which it is found the metal beam - section II, from the T2052 coal extraction machine, following the performing technical expertise. The rehabilitation to which the metal beam - section II assembly will be subjected will be done by executing the intervention works that will bring back to the normal operating parameters both the structural part and the functional part. In the paper are shown: the verification methods of the assembly as well as the proposed technical solutions for its repair.

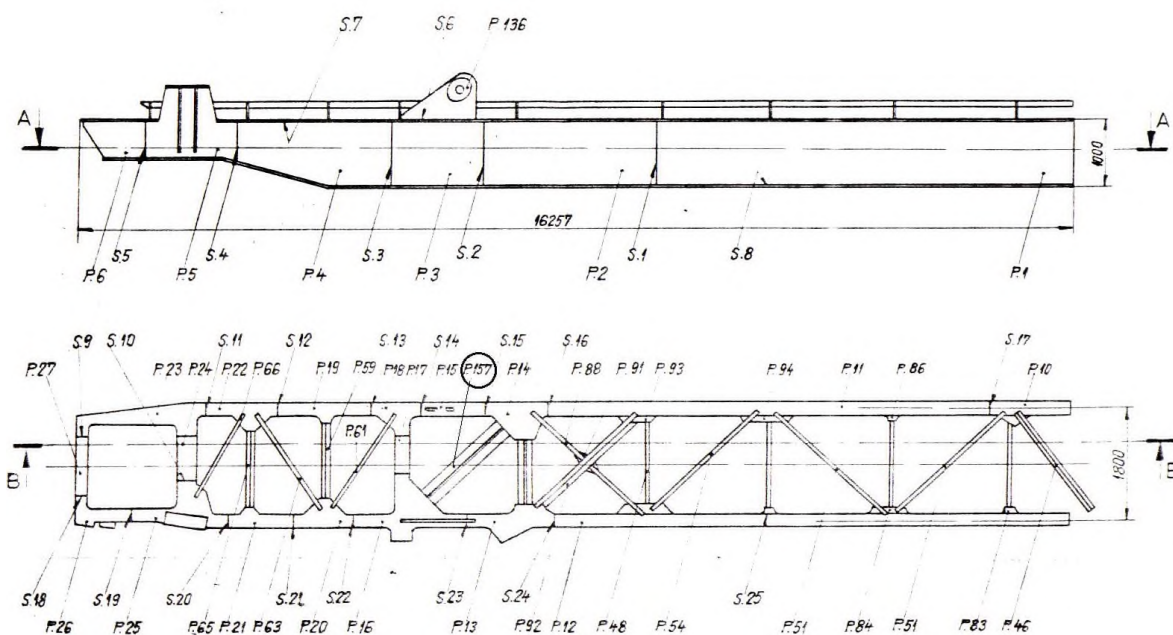
Figure1. Identification sketch for the wheel's arm

The diagonal, see pos.157 of figure 1, was debited oxygas, irregular when mounting the roller support, figure 5. It is recommended to disassemble the support of roller and correct reassembly, polishing and strengthening the diagonal or replacing it.

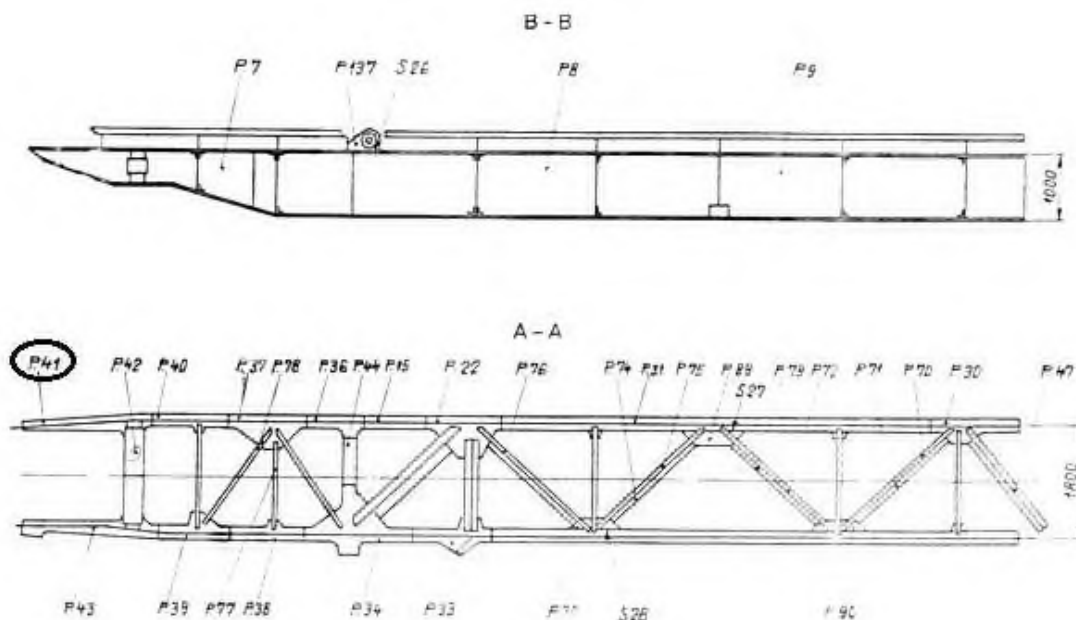
Figure 2. Sketch for the wheel's arm - section III - side view

The transverse beam, see position 41 of figure 2, in the lower field, in the joint area between section I and section II, (on section I) is bent, figure 7. It is recommended to replace it urgently.
