# ON QUALITY CONTROL OF THE FRONT HOOD MARK

**Abstract:** The object of the study is the, Front Hood Panel a component of the car body. The quality checks on the Front Hood Panel are of two types: visual checks and geometry checks. Solutions are proposed to eliminate defects and improve the quality of the part

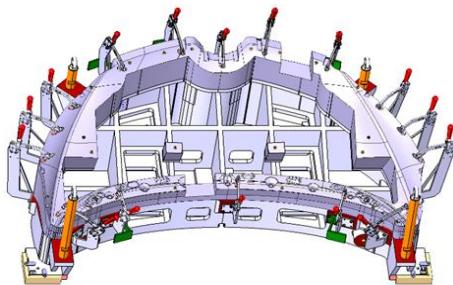
Fig.8.Control layout

These measurements were carried out on three-dimensional measuring machines (fig. 8), which compare the digitized (3D) surface with the measured surface.

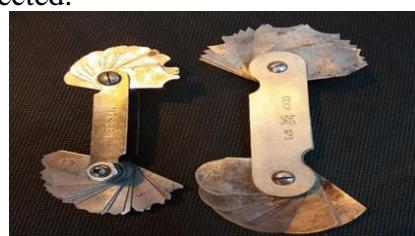
Fig. 14. Rayers measuring rays

Beam measurements are made with the aid of beam meters , fig 14 used in the white light of white-light flashlights. If the beam of light leaks between the beam beam beam and the part, then that beam must be corrected.
